BRIDGE NO.04805

78600 - VOLUNTOWN
FORGE HILL ROAD
over
PACHAUG RIVER

Routine Inspection

8/05/2020

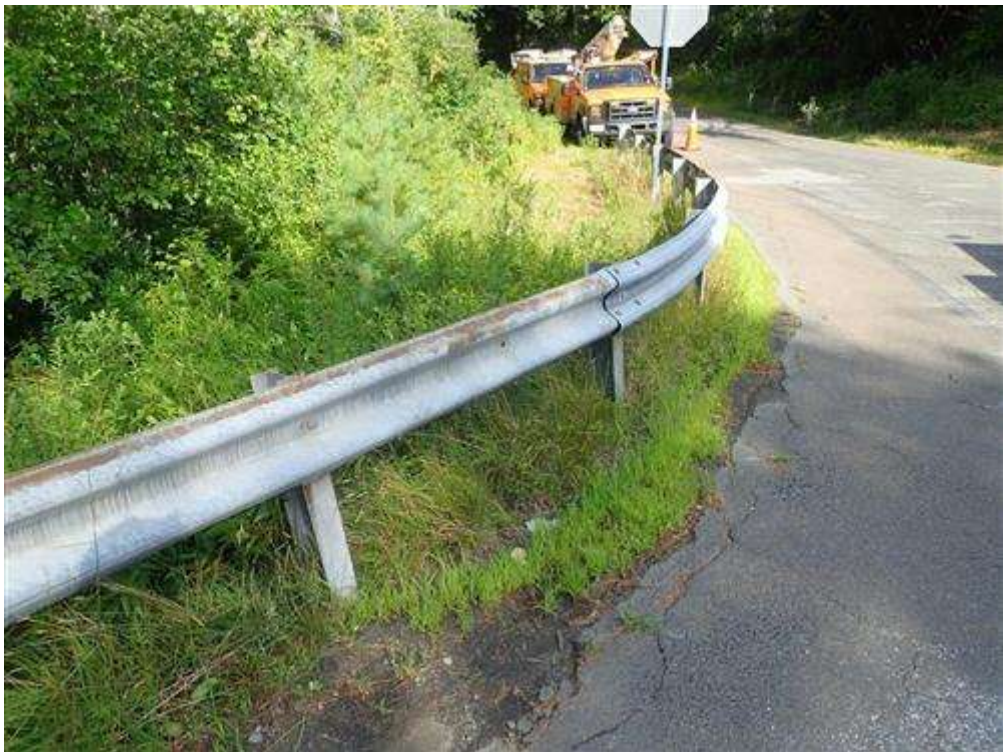
Photo Number: 3

Southbound leading end approach rail.

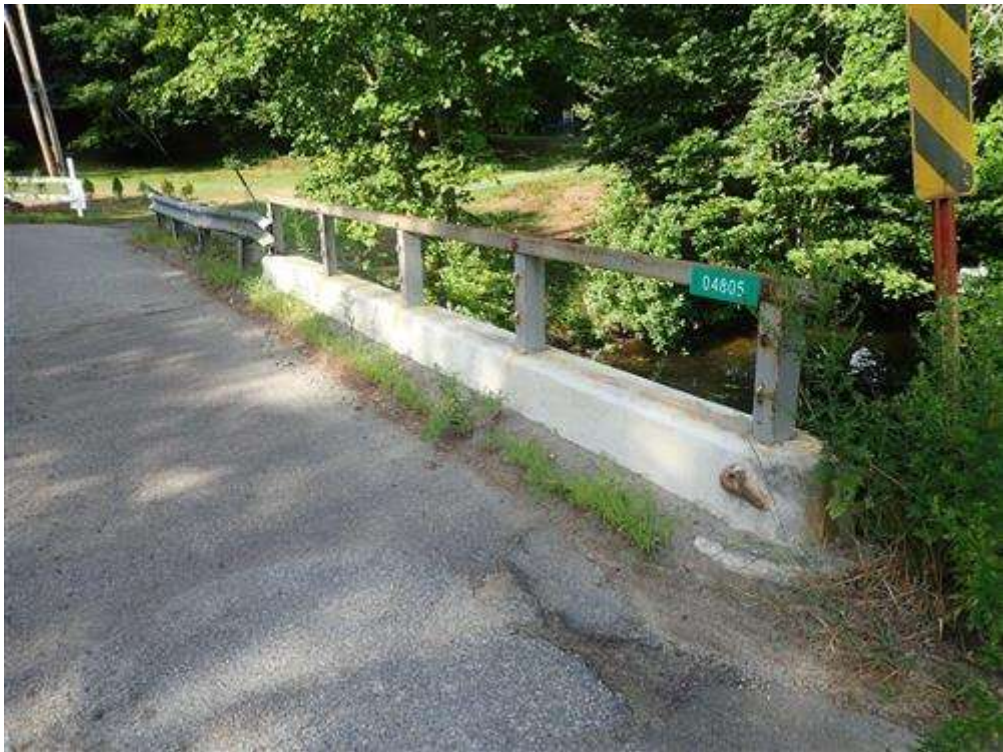
Photo Number: 4

Railing: 7 Angle iron rail and posts:
-Areas of light rust throughout.

-Areas of peeling paint.

Southbound railbase and rail.

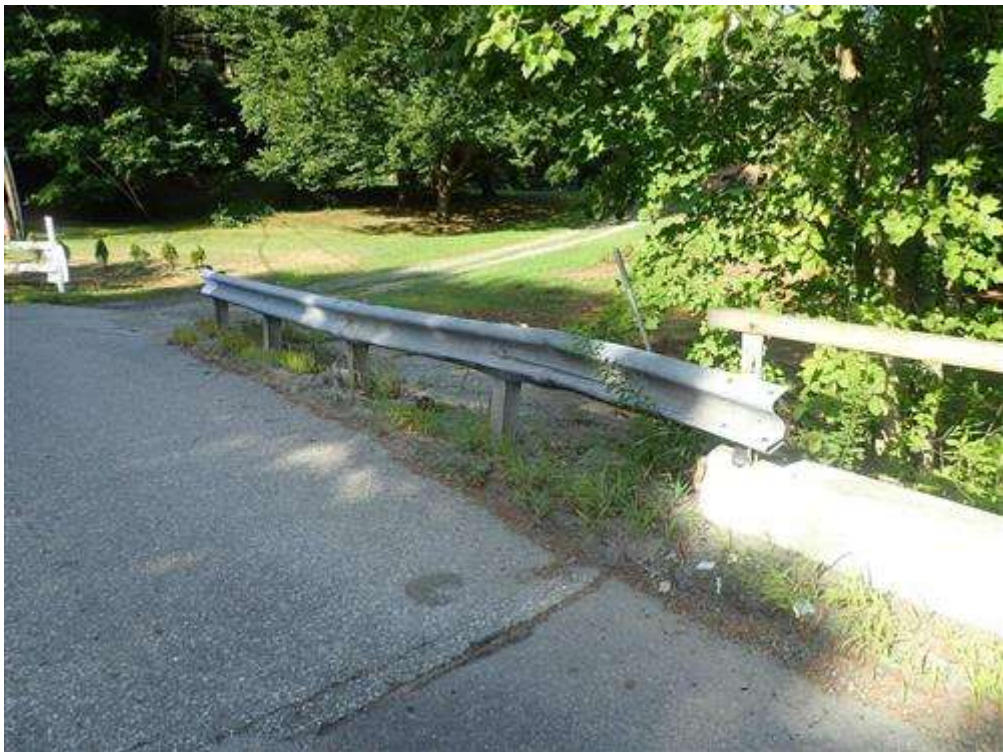
Photo Number: 5

Southbound trailing end:
-(1) Section bent MBR .
-(1) Bent post.

Southbound trailing end approach rail.

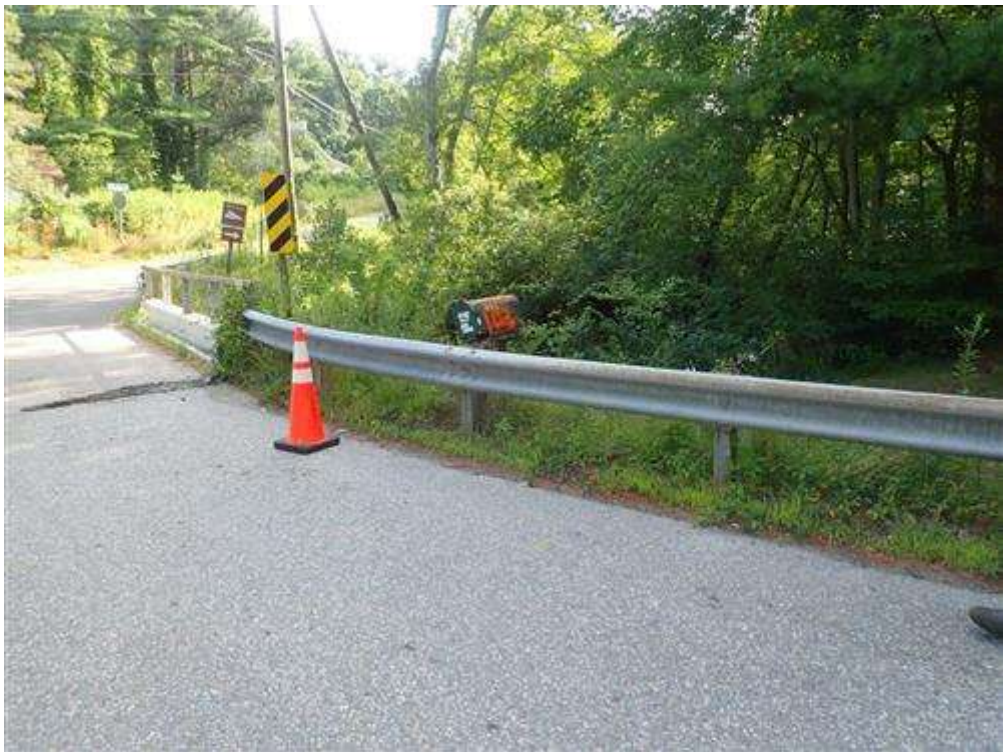
Photo Number: 7

Northbound leading end approach rail.

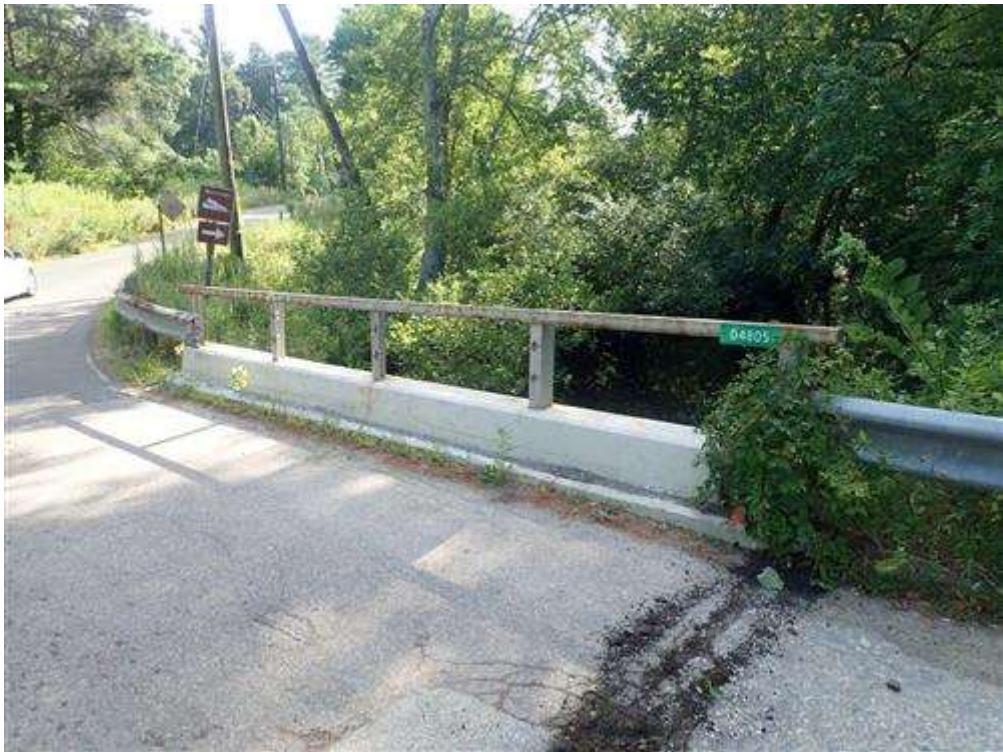
Photo Number: 8

Southbound railbase and rail.

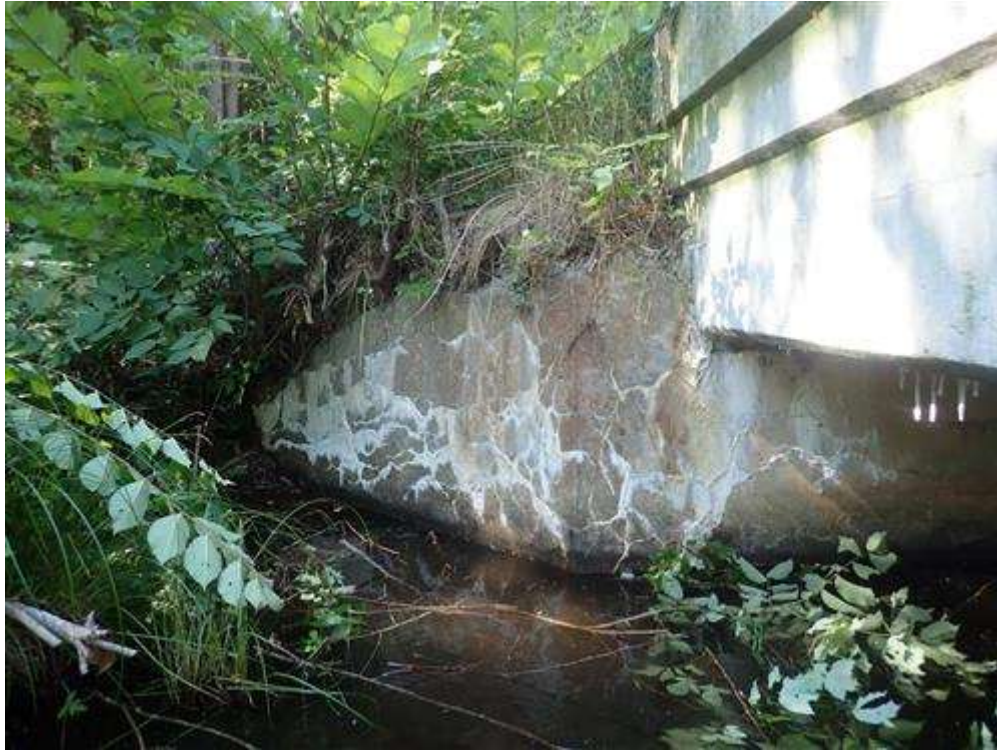
Photo Number: 15

Wingwall 1B.

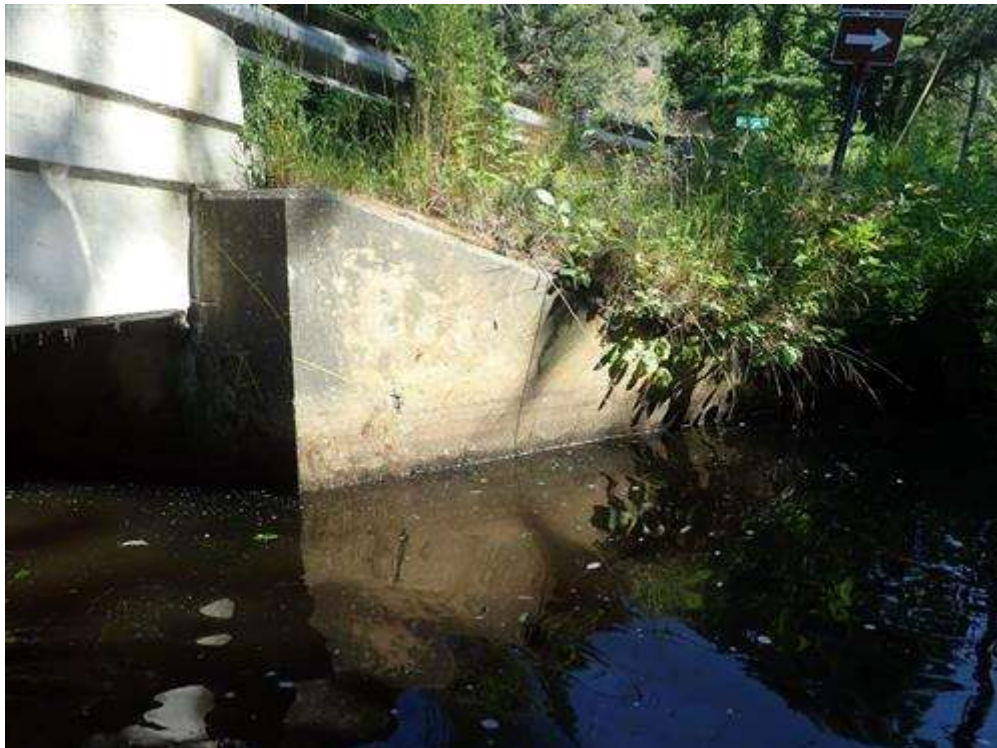
Photo Number: 16

Wingwall 2B.

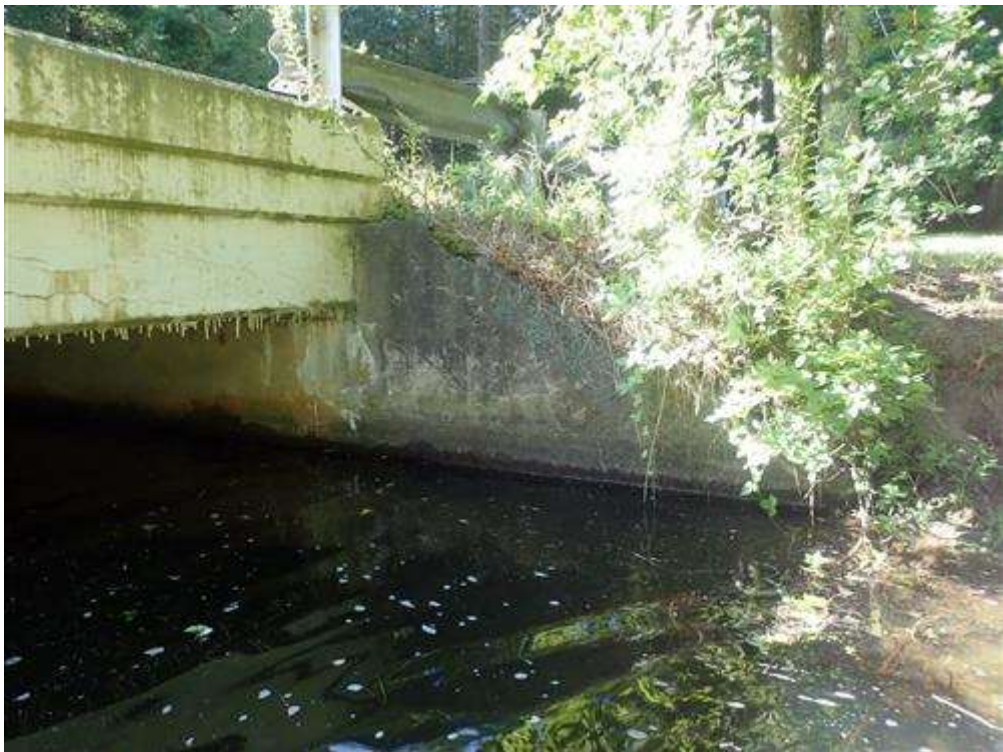
Photo Number: 21

Wingwall 1A.

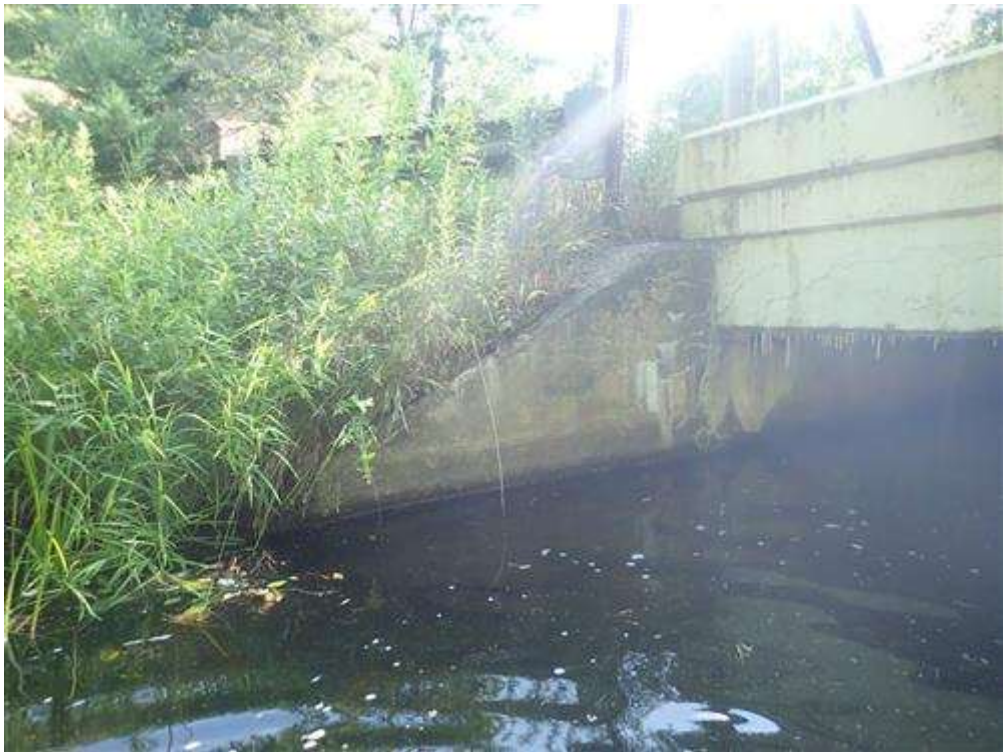
Photo Number: 22

Wingwall 2A.

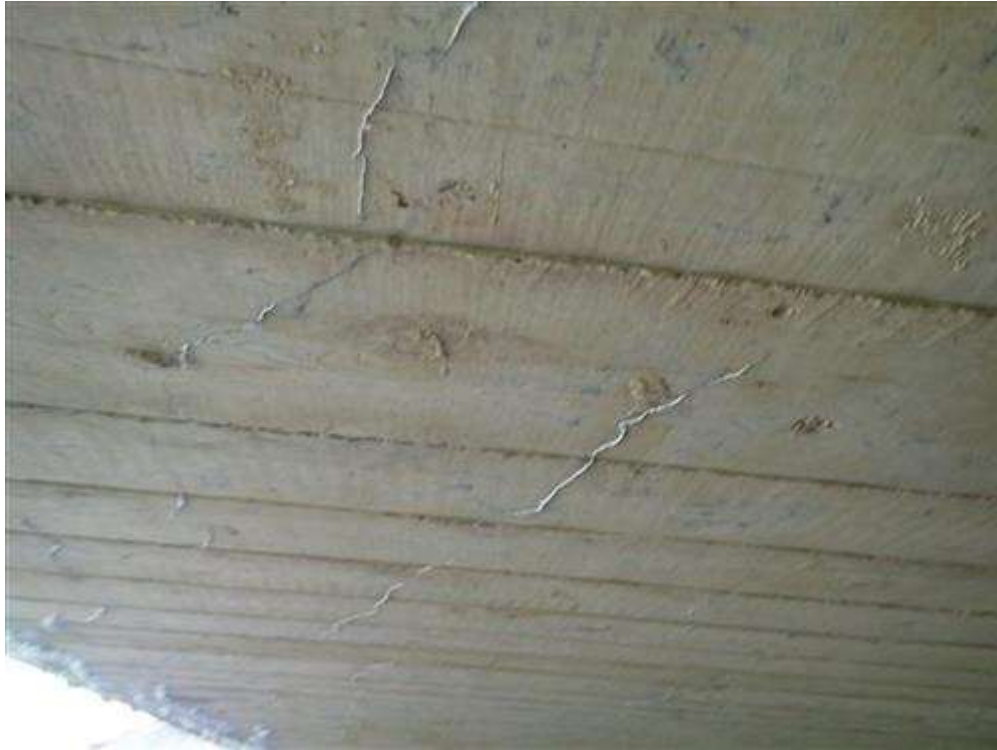
Photo Number: 25

Typical longitudinal cracks with efflorescence at random locations.

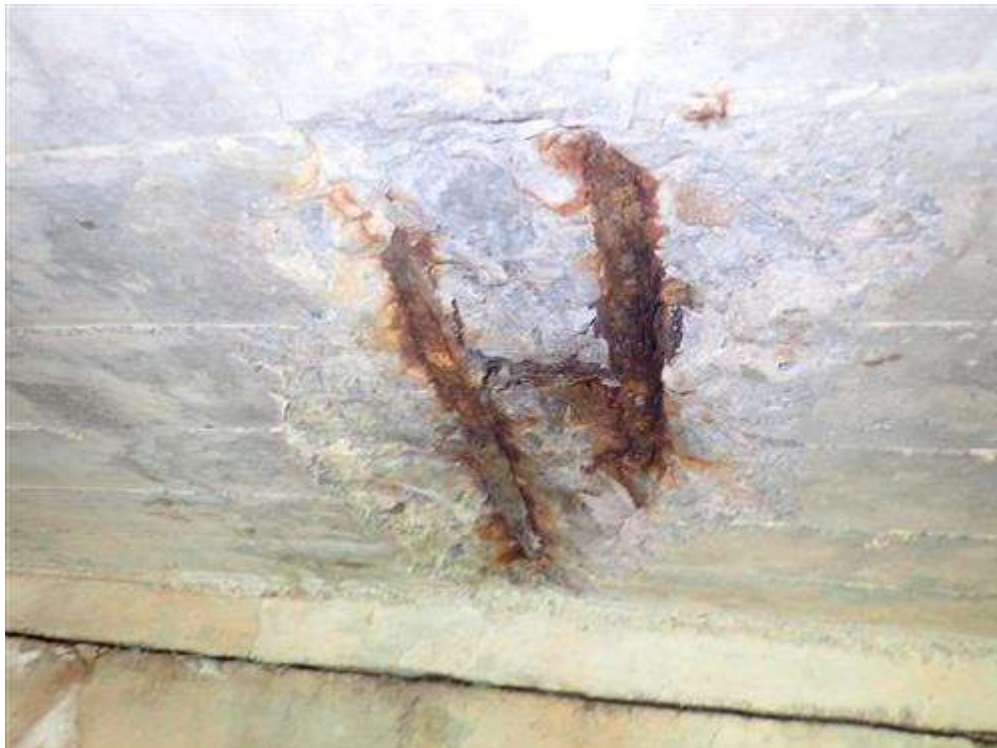
Photo Number: 26

Large surface spall with exposed rebar midspan at A-1.
