### REQUEST FOR PROPOSALS: VOLUNTOWN METHODIST MEETING HOUSE DEMOLITION

RFP#: VOL20232/2023-4

16 October 2013, updated 31 May 2017

Reference: Voluntown Methodist Church - Cursory Structural Conditions Assessment, 2017 Update

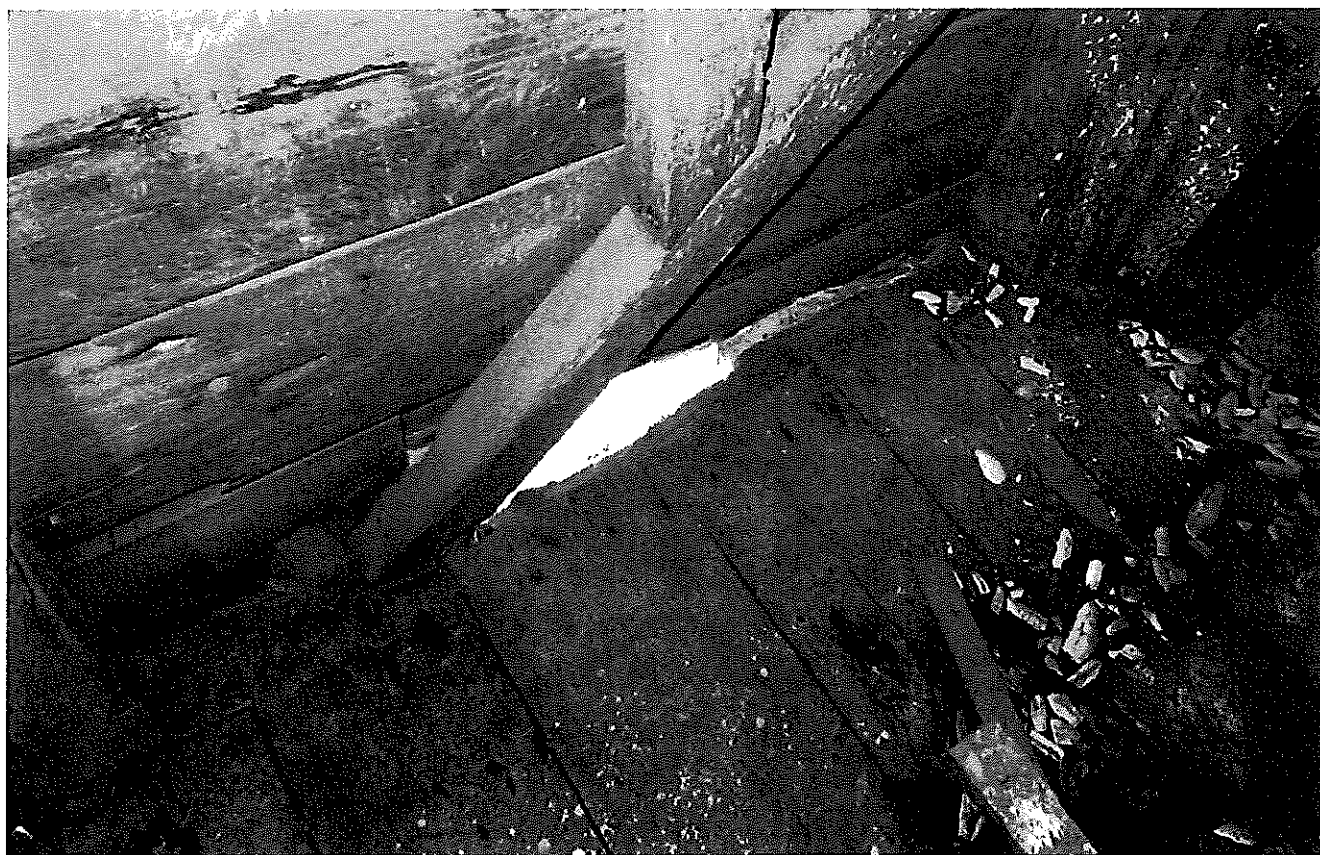
- S-1** Deteriorated sills. 2017 Update: We observed additional sill deterioration and termite damage on both walls adjacent to the north-east corner. 2013: The sill appears to be in a varying state of deterioration along the perimeter of the building. In addition to the area noted in item S-2 below, an outward rotation of the top of several of the granite foundation stones is indicative of deterioration of the outer half of the bottom face of the sill causing rotation of the wall above and foundation below. Deterioration often affects the bottoms of the posts and studs attached to the sill. *All deteriorated sills should be replaced with rot-resistant white oak timbers. In order to better define the scope of sill, post and stud damage, the sill should be further studied and consideration given to exposing it for investigation in certain locations. See below for discussion of immediate make-safe repair recommendations.*

**S-1** Deteriorated sill, north-east corner (2017)

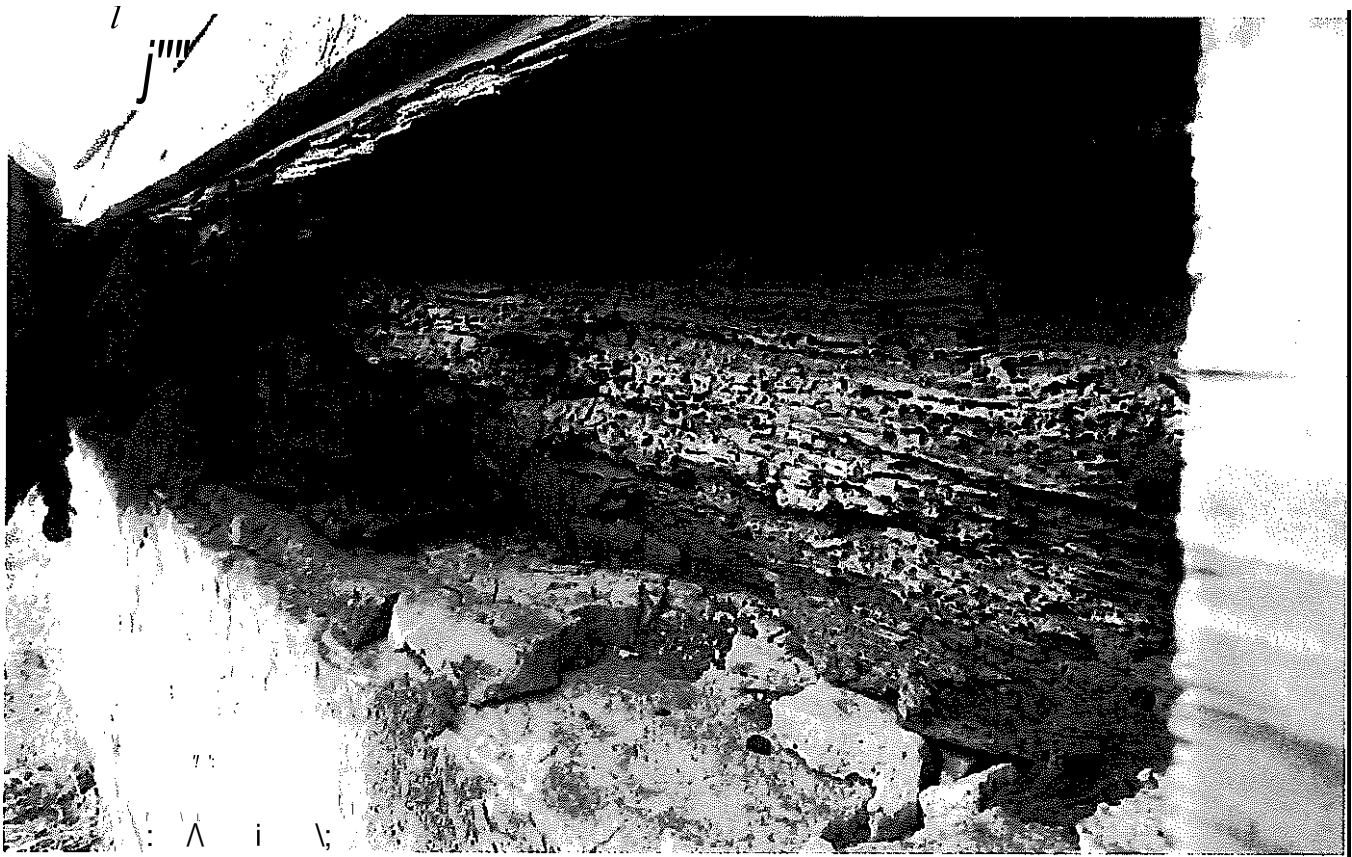
S-1 Deteriorated sill, east side (2017)

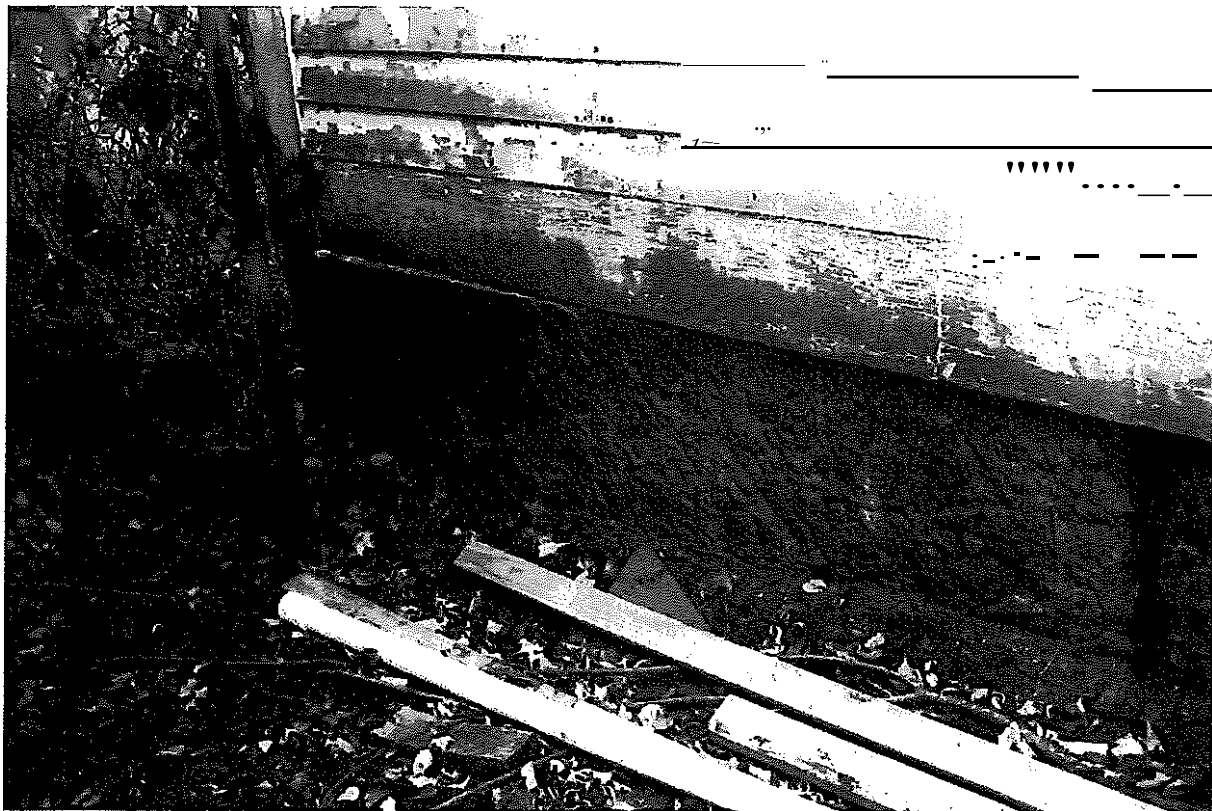
S-2 Shifting at foundation below sill, north-west corner (2013)

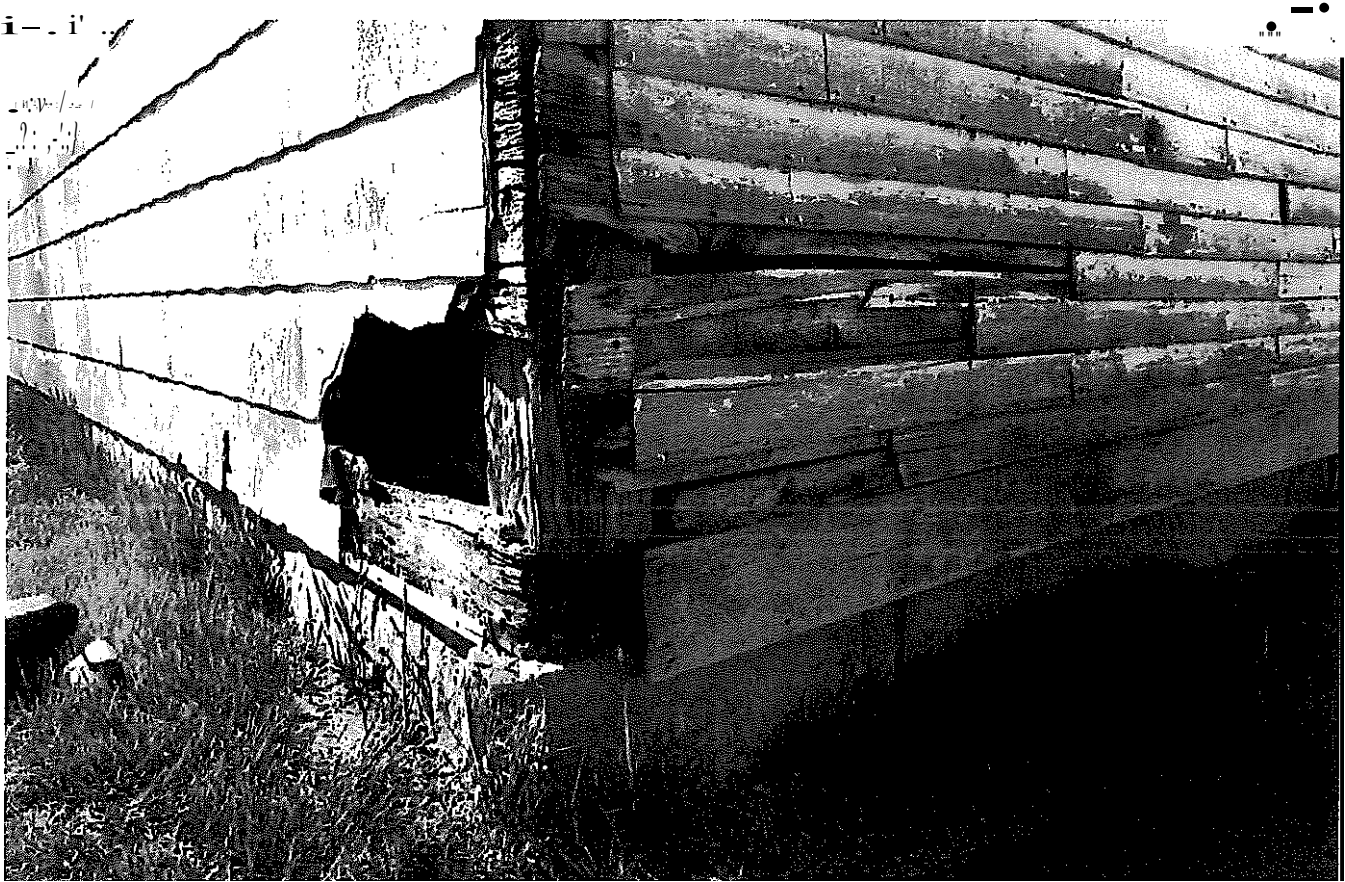
- S-2** South-east corner deterioration. 2017 Update: Shoring was not performed in this area and still remains compromised. 2013: Severe deterioration is evident in the south-east corner due to a breach in both the siding and cornice / roof in this area. There is very little integrity left in the sill or post-base, and eave beam and connecting rafters also appear to be compromised. The roof load in this corner has been shed to the adjacent studs; *however the sill, post, braces and possibly eave beam and rafter tails in this area must be replaced to restore full integrity. See below for discussion of immediate make-safe repair recommendations.*

S-2 Deterioration at south-east corner (2017)

to the south-east corner and at the failed members below the former tower on the north elevation, particularly the currently unsupported roof purlins.

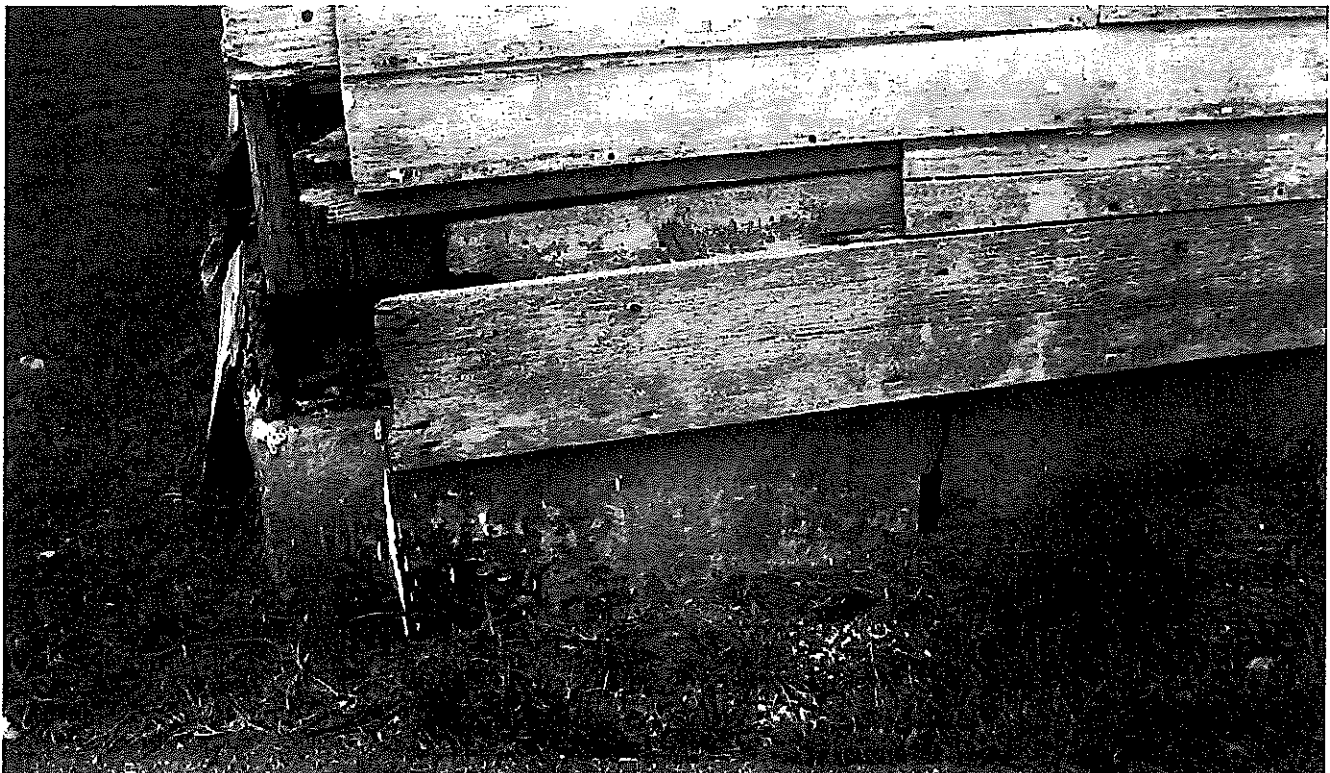
S-2 Deterioration at south-east corner (2013)

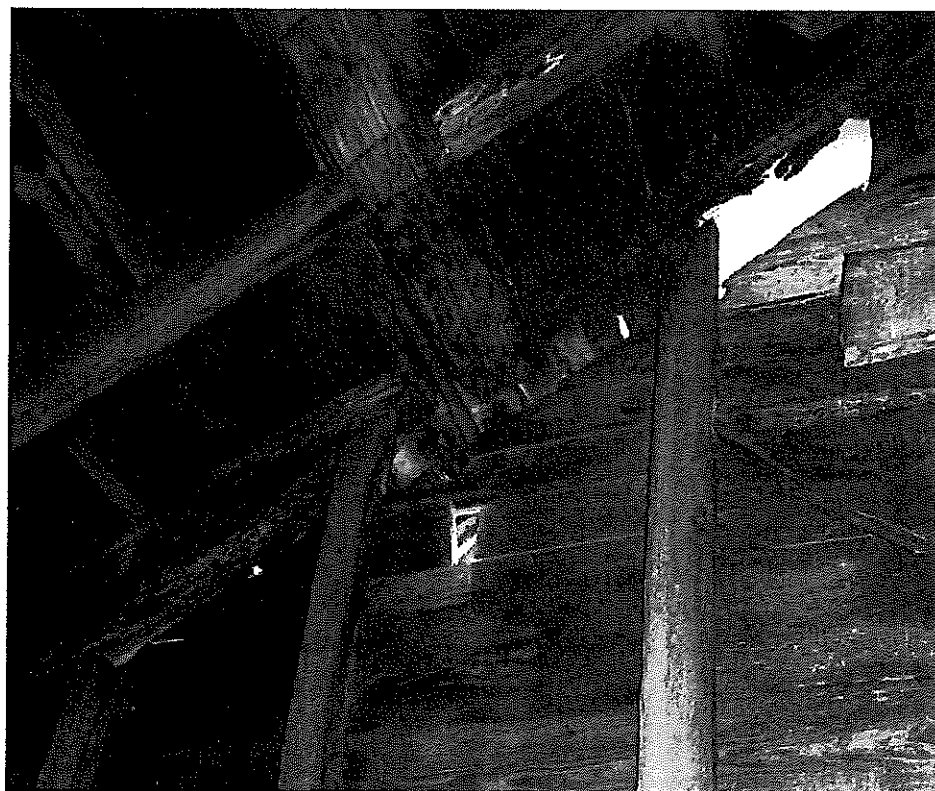
- S-3** Deterioration below tower. 2017 Update: Shoring was installed in early 2014. Deterioration of the framing has continued due to roof and siding breaches

creating additional areas of limited ability to support the end bay of the roof and north wall. Without structural intervention, there is no guarantee that this area can support snow, hurricane or seismic loads, and with continued deterioration this area may lose its ability to support its own dead loads. 2013: The roof and wall framing on the north elevation that once supported the tower has seen severe deterioration due to breaches in the roofing and siding. The raking end rafters have severed where the mid-slope purlin frames in on both east and west sides. The west side remains unsupported and the east side is shored with a temporary, but undersized, stud. The wind girt running at eave level is also severely compromised. *We recommend that all compromised members be replaced. Should a comprehensive restoration plan include resetting the tower, the former tower posts should all be assessed for condition and integrity. See below for discussion of immediate make-safe repair recommendations.*

**S-3** Deteriorated rafter and purlin connection on west slope of north wall (2013)

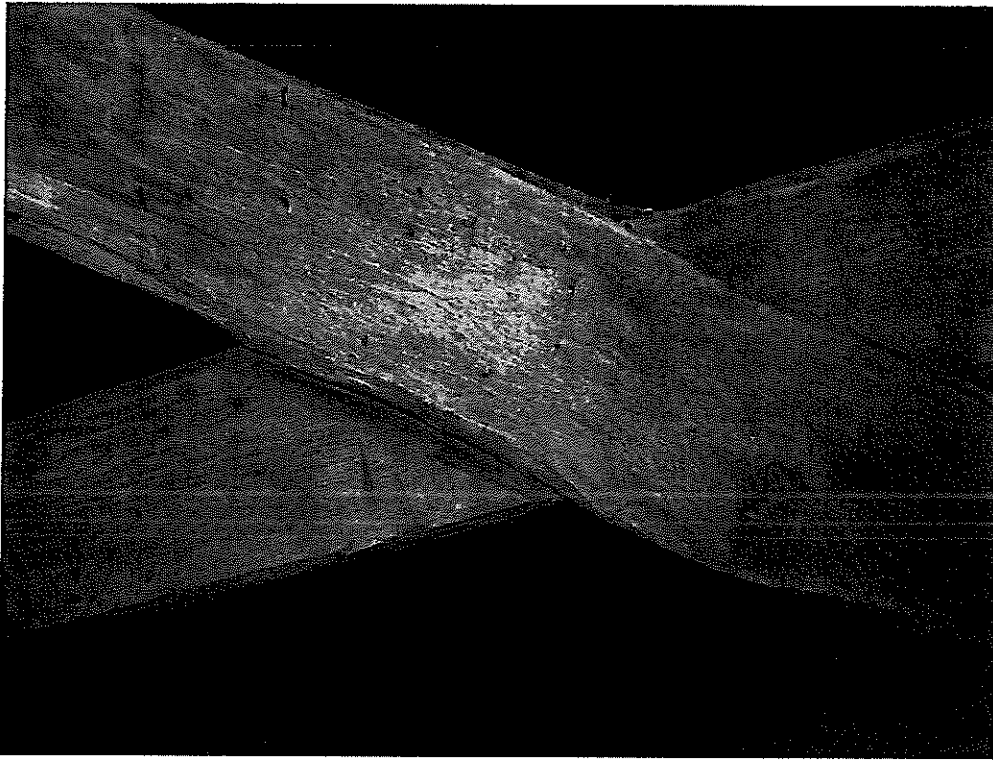
**S-4** Scissor truss separation. 2017 Update: Eave to eave cables were installed in early 2014. We were not able to evaluate whether lateral thrust loads are currently being supported by existing truss joinery at the eaves, or if joinery failures have occurred causing thrust loads to be transferred to cables. 2013: By nature scissor trusses have a tendency to spread due to the indirect orientation of the eave restraint, as opposed to direct eave to eave restraint typical of other truss types. In this case, I observed some minor separation at the scissor cross as well as some bowing at the eave on the east wall. I was not able to assess the integrity of the eave joint. *The truss should be more closely studied during a comprehensive restoration program to determine whether the joints require reinforcement. See below for discussion of immediate make-safe repair recommendations.*

S-4 Joint opening at east eave end of scissor-cross (2013)

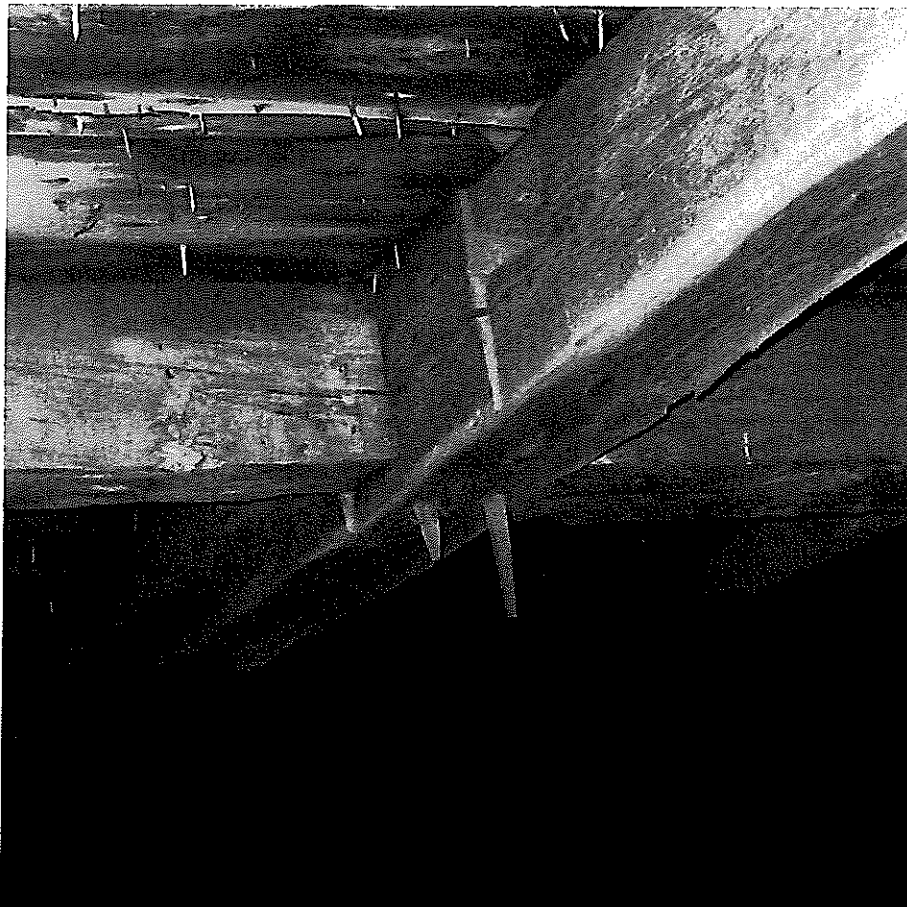
**S-5** Purlin Connection Splitting. 2017 Update: We did not observe any change in this condition. 2013: Horizontal splits are evident in the purlin at the connection to the trusses. The splits are evidence of a shear stress concentration where the purlin end is reduced into the mortise. *There are a number of joint reinforcement details that could be employed to address this problem during a comprehensive restoration project.*

S-5 Horizontal shear split in purlin end (2013)
