BRIDGE NO.04805

78600 - VOLUNTOWN
FORGE HILL ROAD
over
PACHAUG RIVER

Routine Inspection

8/05/2020

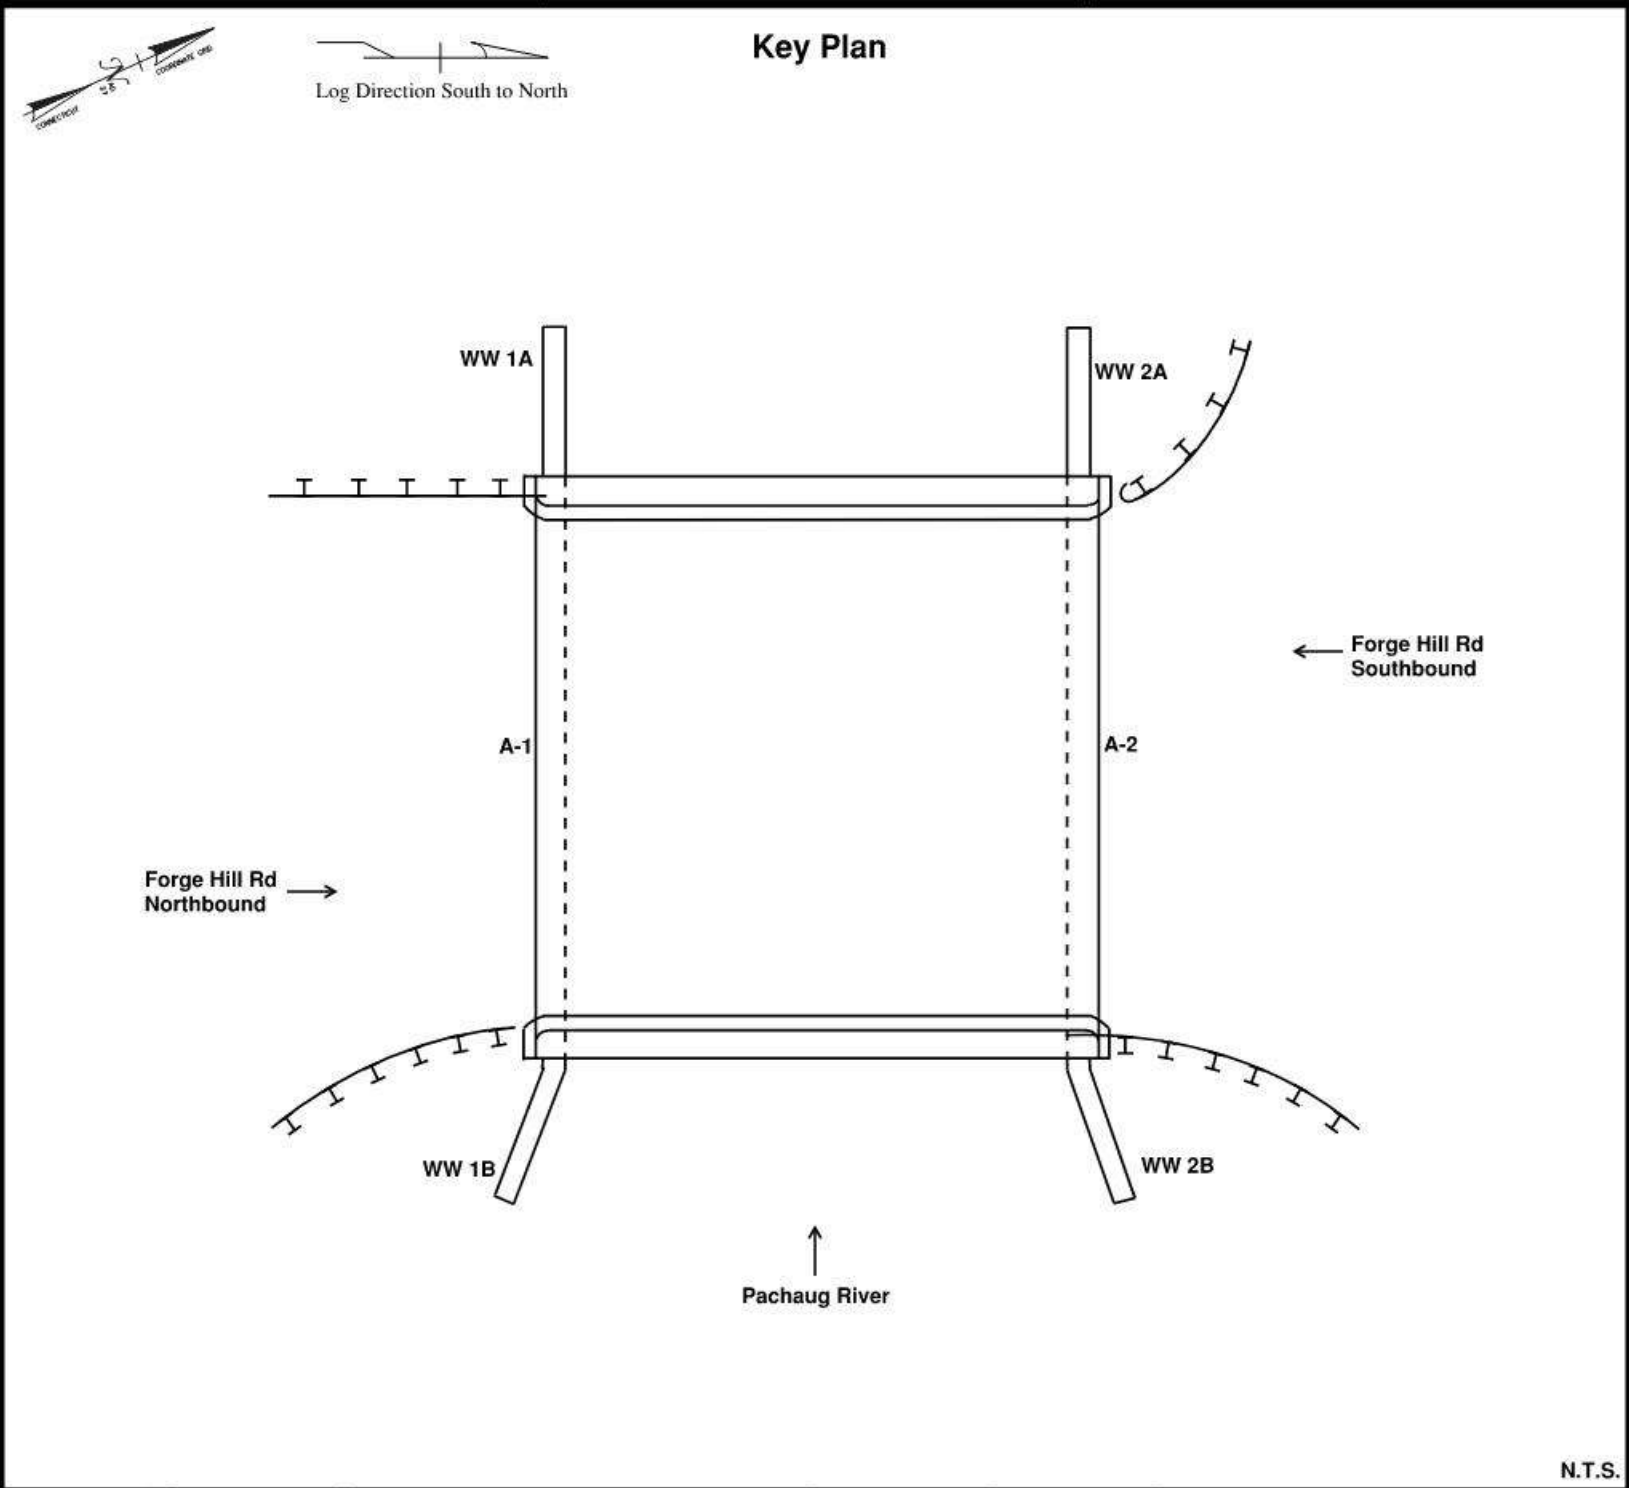
-Delaminated along both curb lines full length up to 8 feet wide.(see sketch)

-Full width transverse cracks at deck ends open up to 1 in. with adjacent bituminous breaking up and patched areas.

-Large bituminous patched areas with heaved and settled areas.

-Large surface spall 26 in. x 13 in. x 2 1/2 in with exposed deck.

-± 20 SF patched area (settled up to 1/2 in.)with adjacent bituminous breaking up.

See attached sketch.

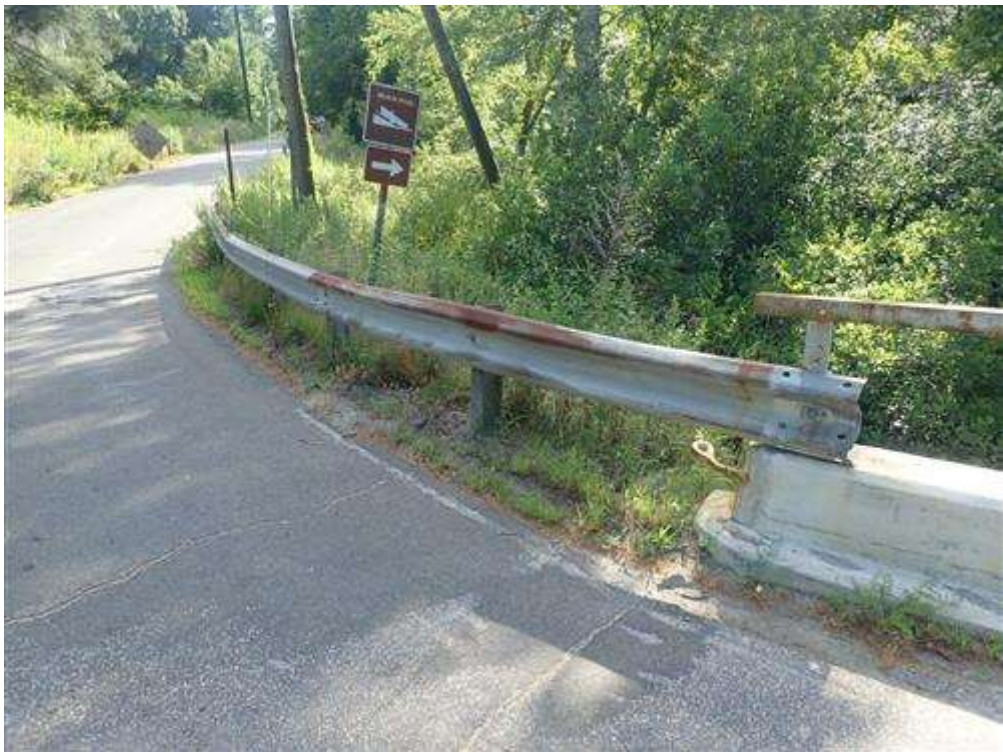
Photo Number: 9

Southbound trailing end:
-(1) Section bent MBR .
-(1) Bent post.

Southbound trailing end approach rail.

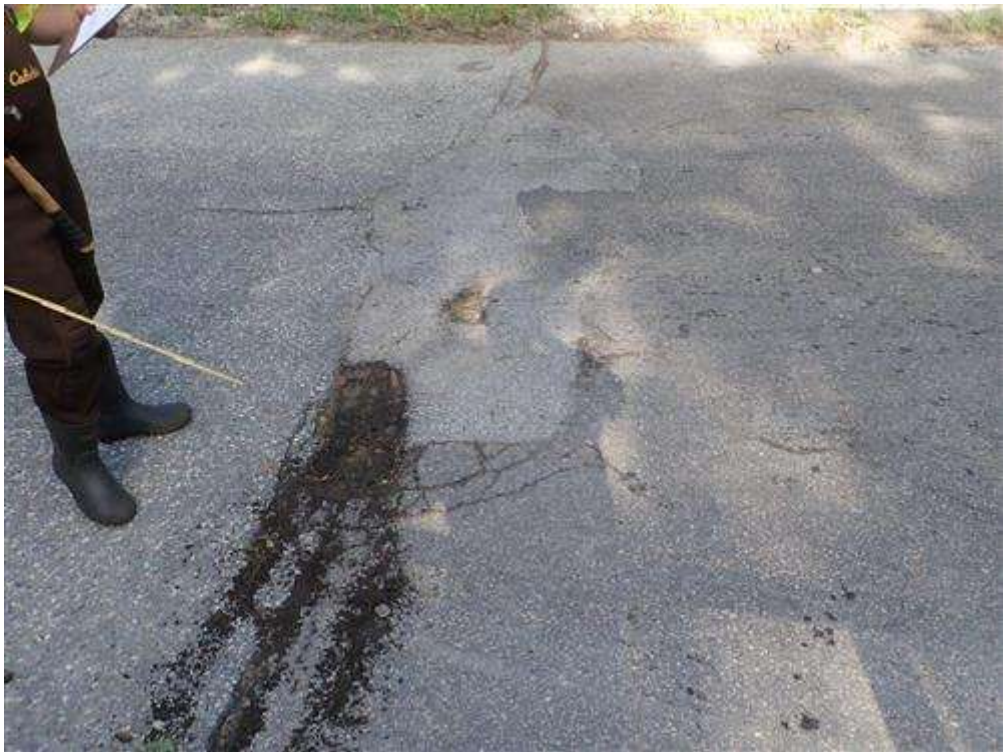
Photo Number: 10

South deck end.

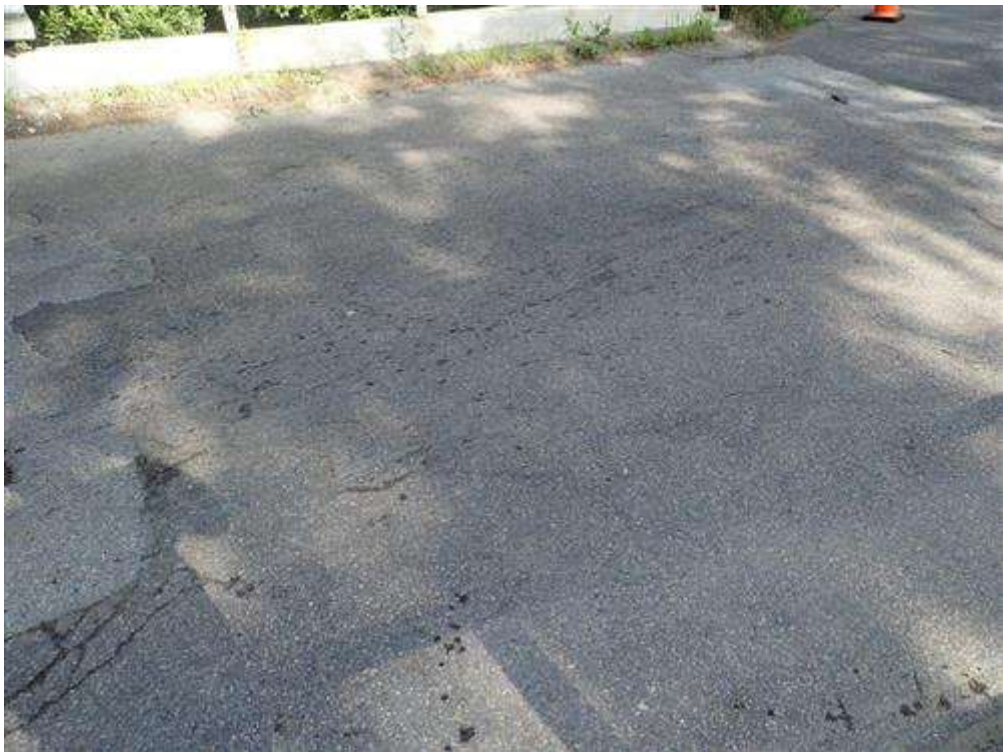
Photo Number: 11

-Transverse, longitudinal and random cracks open 1/2 inch.

Overlay.

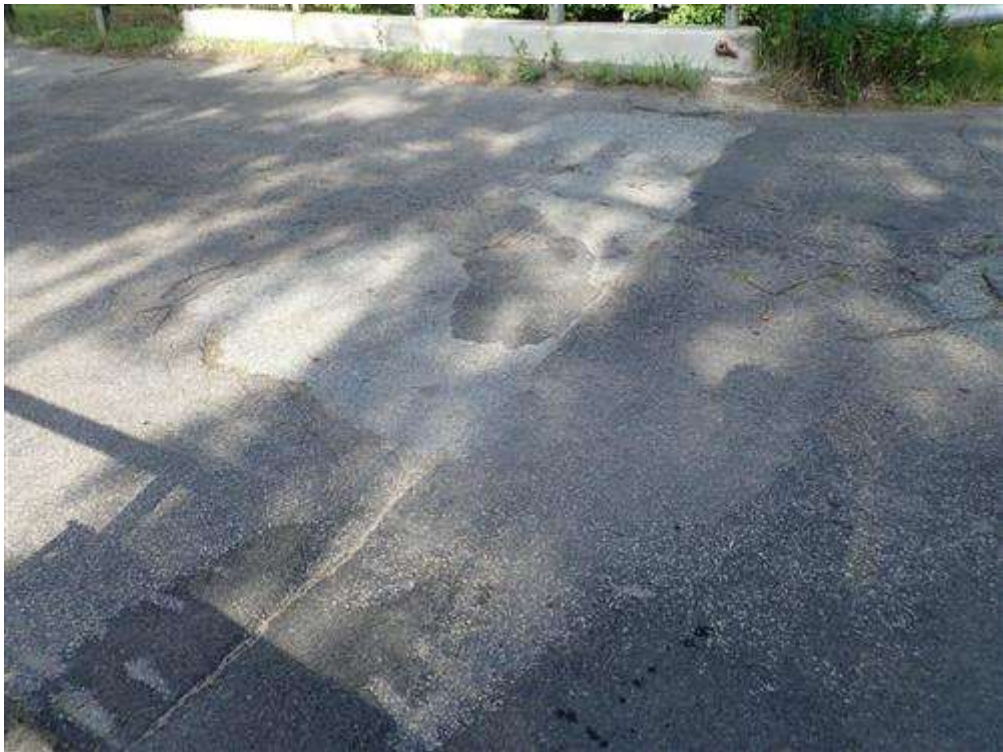
Photo Number: 12

North deck end.

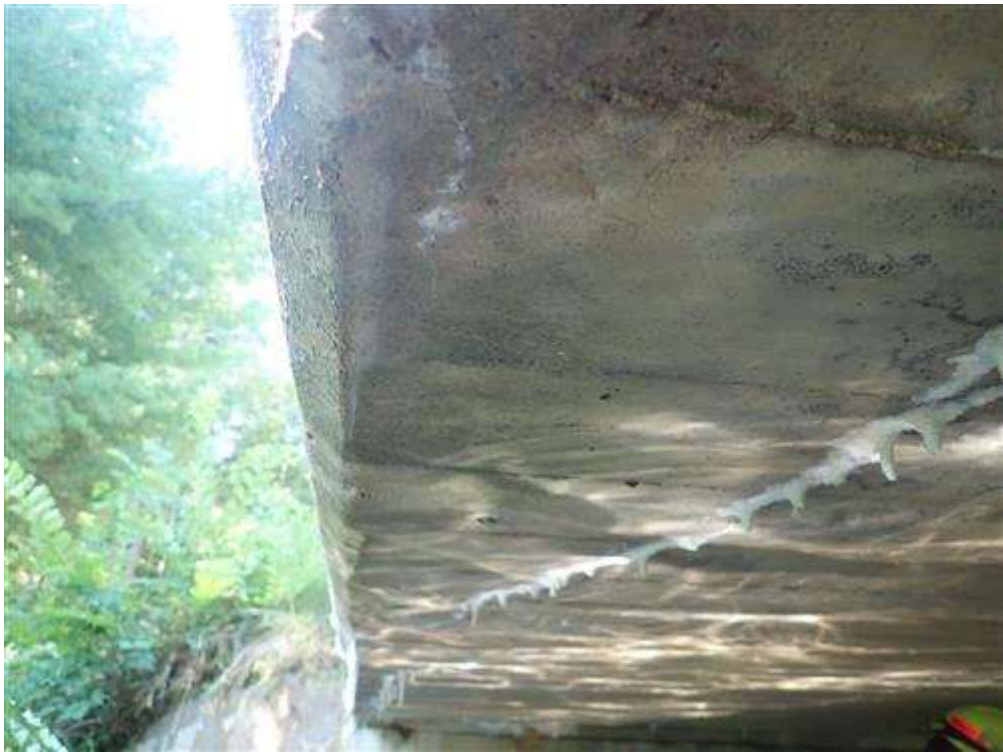
Photo Number: 18

View of cracking on deck underside at the inlet end.

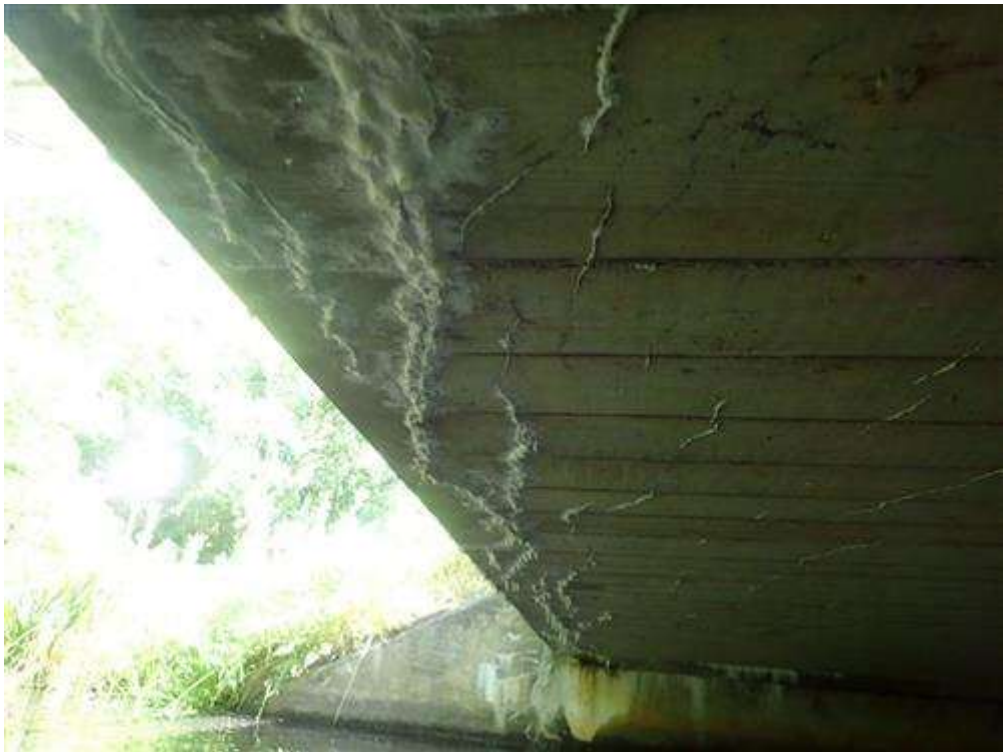
Photo Number: 24

View of cracking on deck underside at the outlet end.

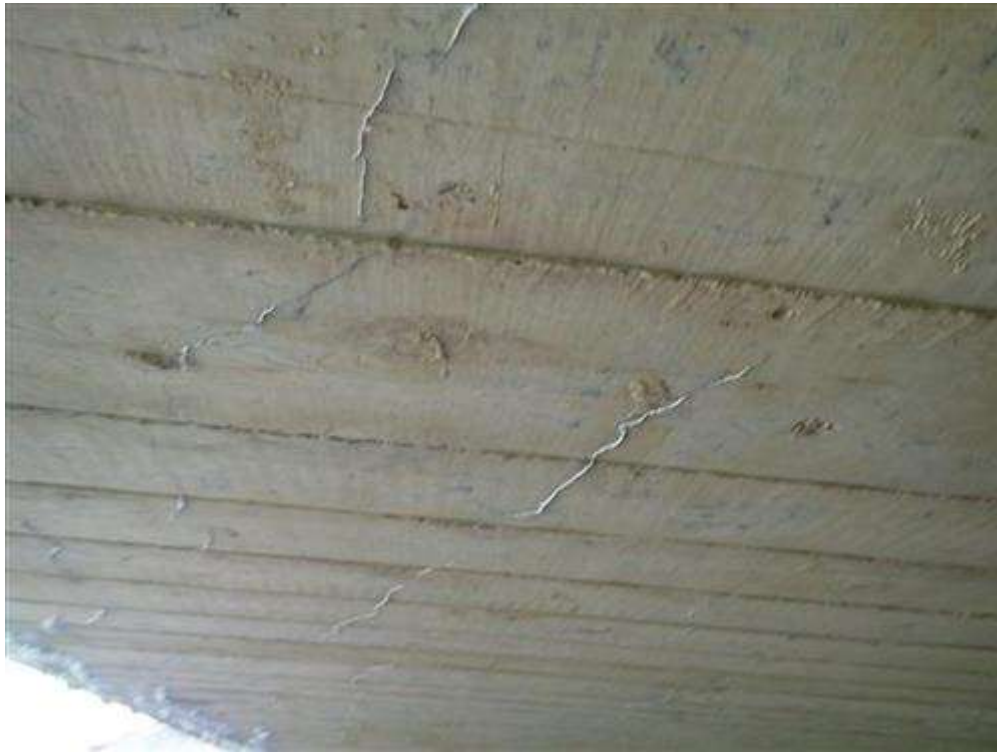
Photo Number: 25

Typical longitudinal cracks with efflorescence at random locations.

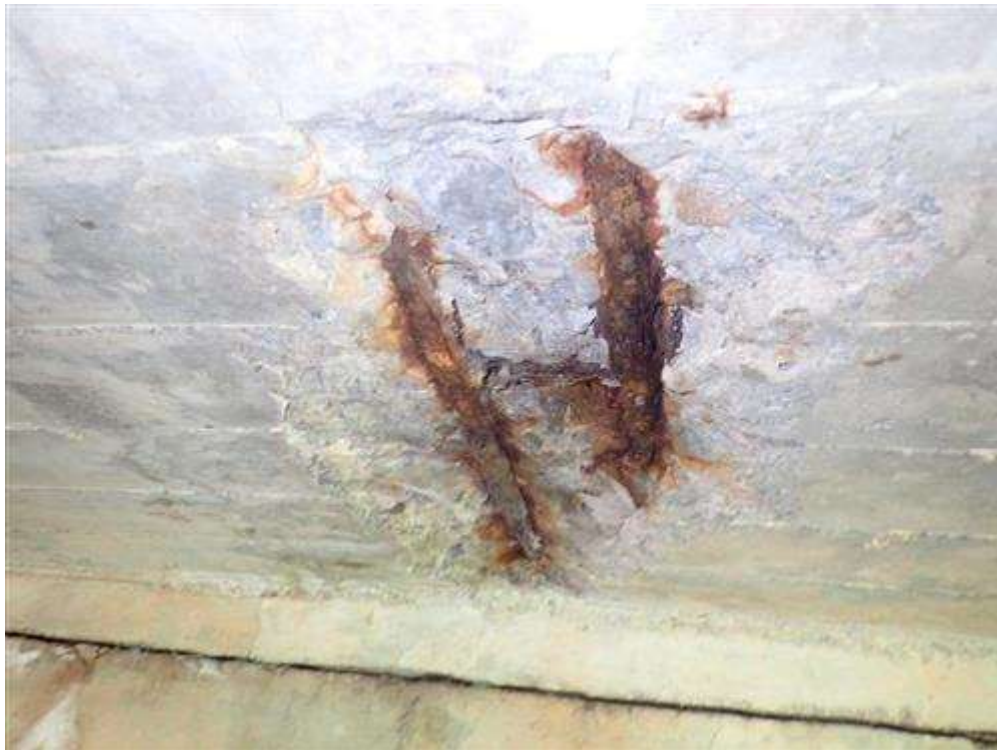
Photo Number: 26

Large surface spall with exposed rebar midspan at A-1.

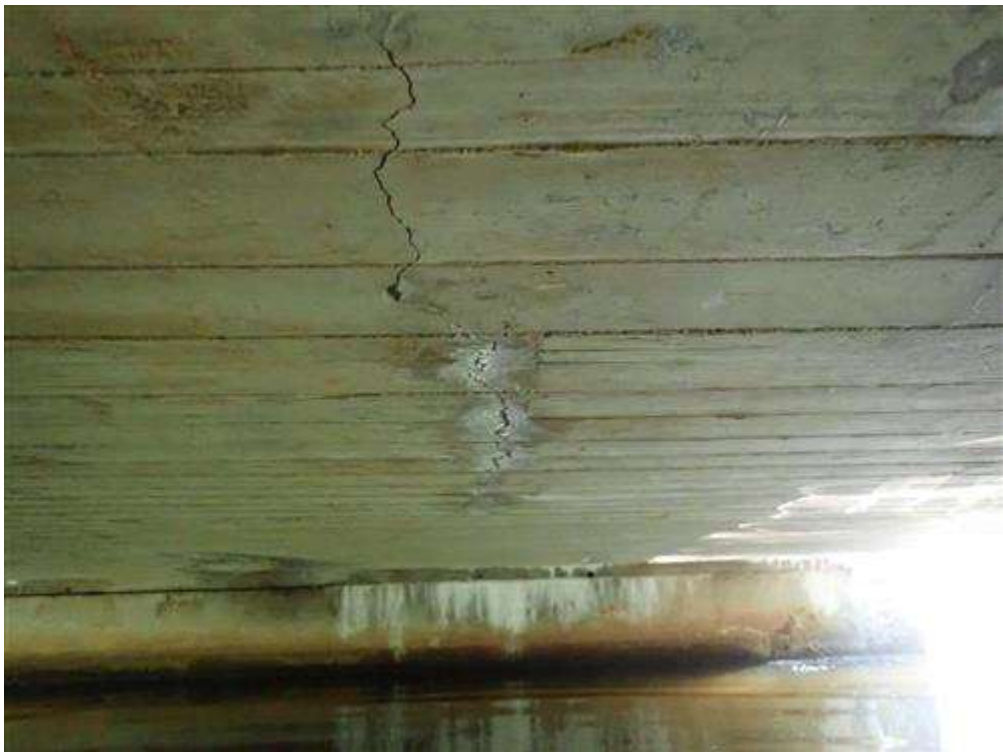
Photo Number: 27

Longitudinal crack open up to 1/8 inch with efflorescence near midspan.

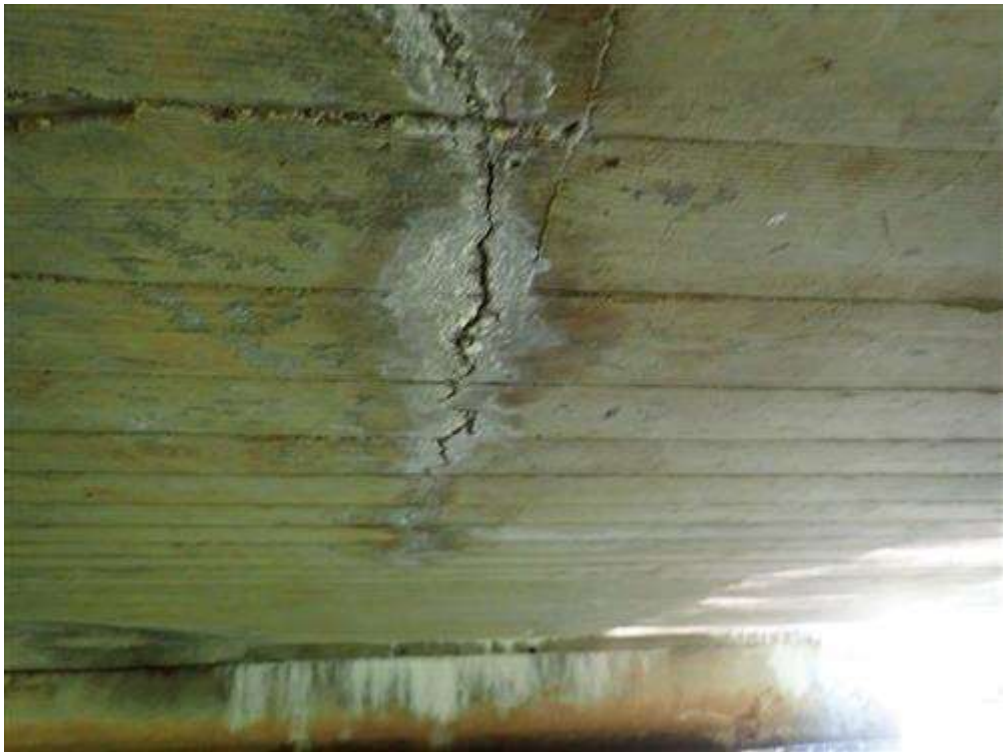
Photo Number: 28

Close up view of longitudinal crack open up to 1/8 inch with efflorescence near midspan.

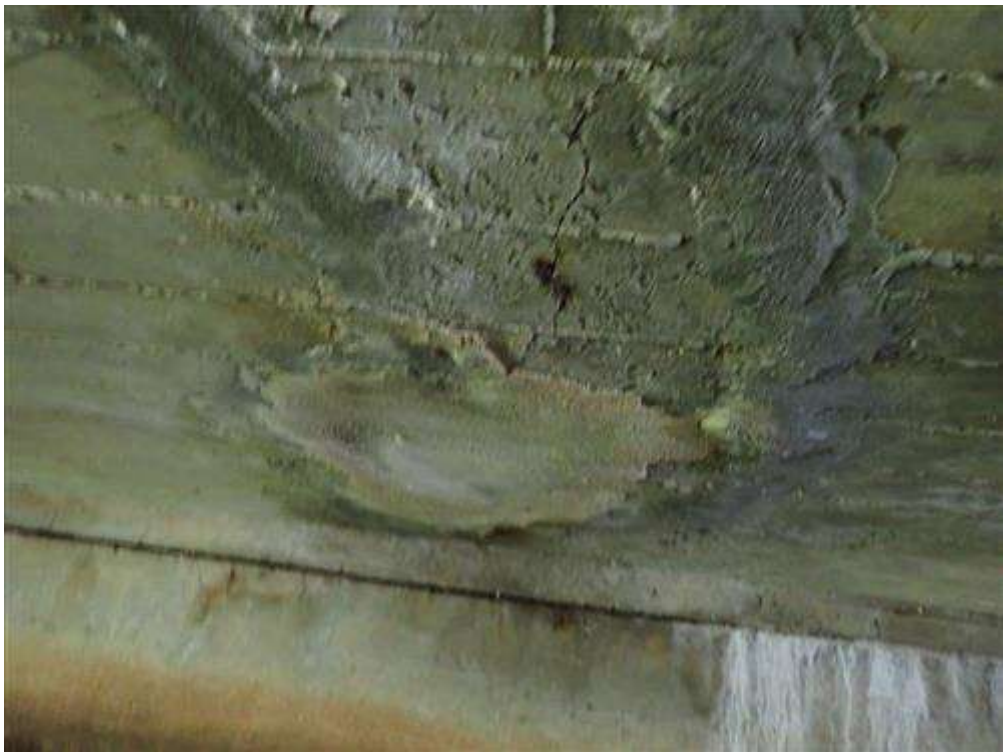
Photo Number: 29

Large patch midspan near A-2 with hollow areas and longitudinal cracks.

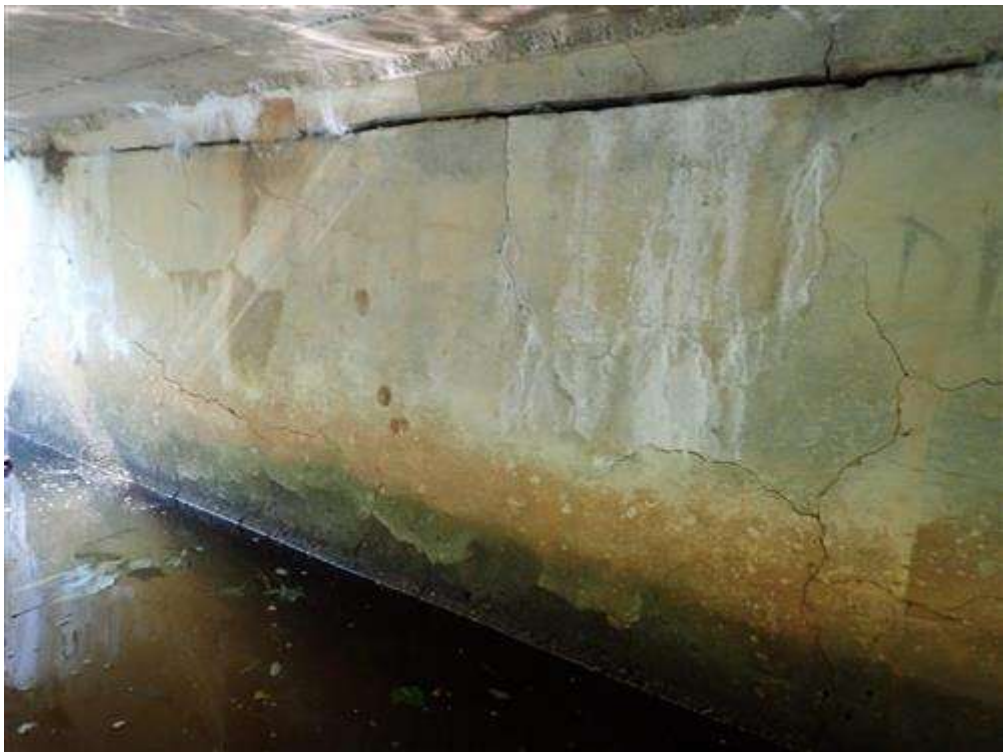
Photo Number: 31

Abutments - Stem:	5	Reinforced concrete: -Horizontal, vertical and diagonal cracks open from hairline to .070 inch with and without efflorescence. -Gap between bottom of deck and top of abutments, up to 3/8 in. in random areas (appears to be an as built condition). -Light to medium scale at and below the waterline up to 24 inches high. -Large hollow areas. -See attached sketch.
Abutments - Backwall:	N	
Abutments - Footings:	N	Not visible.
Abutments - Settlement:	8	
Abutments - Wingwalls:	5	Reinforced concrete: -Light to medium scale at and below the waterline up to 24 inches high. -Map hairline cracks open up to .050 inch with and without efflorescence on all wingwalls. -Overburden (earth build up) on top of all wingwalls. Wingwall 1B: -Hollow area, 8 square feet. -Severe scale area and heavy efflorescence at the top, 4 ft. long x 4 in. deep x full width. Wingwall 2A: -Free end has an area of severe scale / spall 2 square feet X 2 in. deep. -Hollow area at top, 12 square feet. Wingwall 2B: -Hollow area adjacent to abutment, 20 square feet.

Typical cracking on abutment #1.
