REQUEST FOR PROPOSALS: VOLUNTOWN METHODIST MEETING HOUSE

Methodist Meeting House – Voluntown CT – Existing Conditions photos 6/15/2022

Reference: Voluntown Methodist Church - Cursory Structural Conditions Assessment, 2017 Update

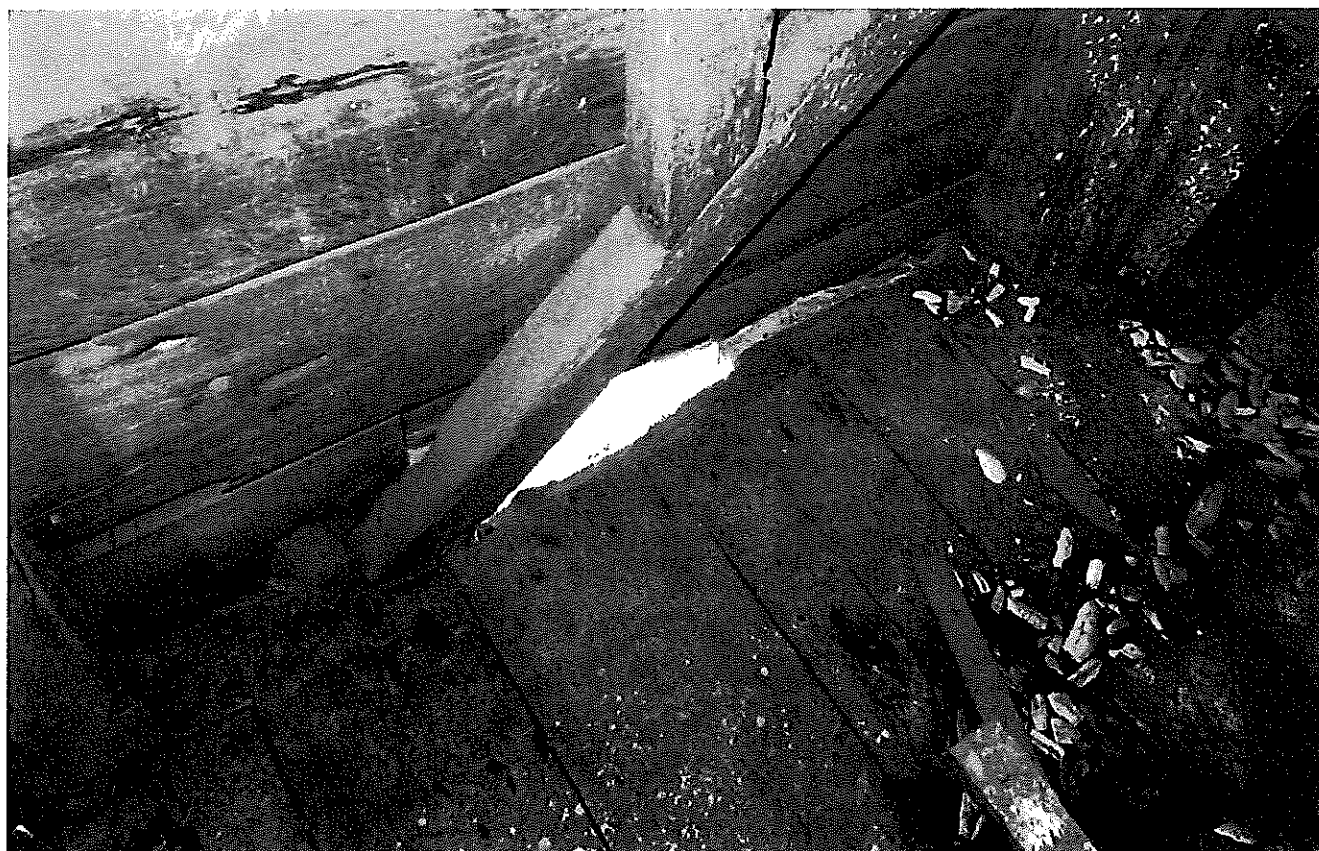
- S-1** Deteriorated sills. 2017 Update: We observed additional sill deterioration and termite damage on both walls adjacent to the north-east corner. 2013: The sill appears to be in a varying state of deterioration along the perimeter of the building. In addition to the area noted in item S-2 below, an outward rotation of the top of several of the granite foundation stones is indicative of deterioration of the outer half of the bottom face of the sill causing rotation of the wall above and foundation below. Deterioration often affects the bottoms of the posts and studs attached to the sill. *All deteriorated sills should be replaced with rot-resistant white oak timbers. In order to better define the scope of sill, post and stud damage, the sill should be further studied and consideration given to exposing it for investigation in certain locations. See below for discussion of immediate make-safe repair recommendations.*

S-1 Deteriorated sill, north-east corner (2017)

2017 Update: In 2014, shoring was installed to support the north elevation and cables installed at the eaves of the trusses. Shoring was not constructed in the south-east corner. 2013: We recommend that temporary support be added as soon as possible to ensure the stability of the building in the upcoming winter / snowy months. Cables should be constructed to connect the east and west eave beams beneath each of the interior trusses; these should be made snug-tight with a turnbuckle but not tensioned. Temporary support should be added

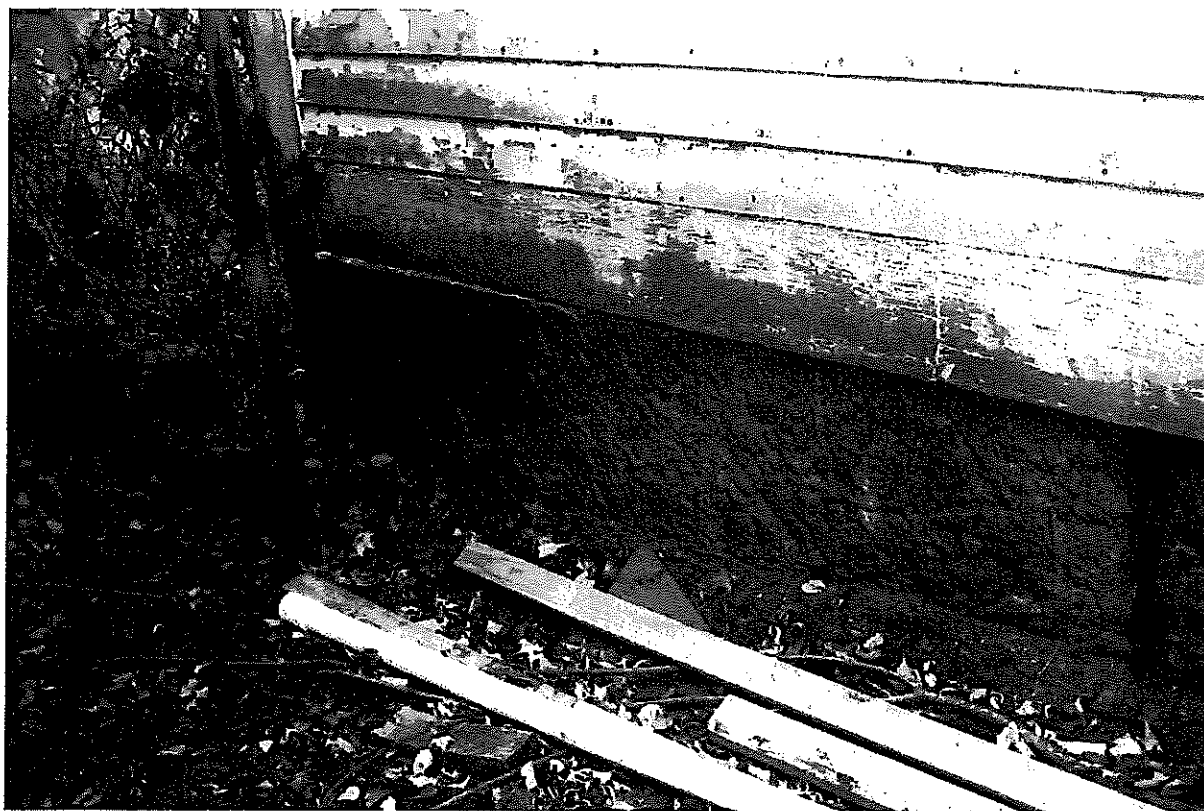
S-1 Shifting at foundation below sill, north-west corner (2013)

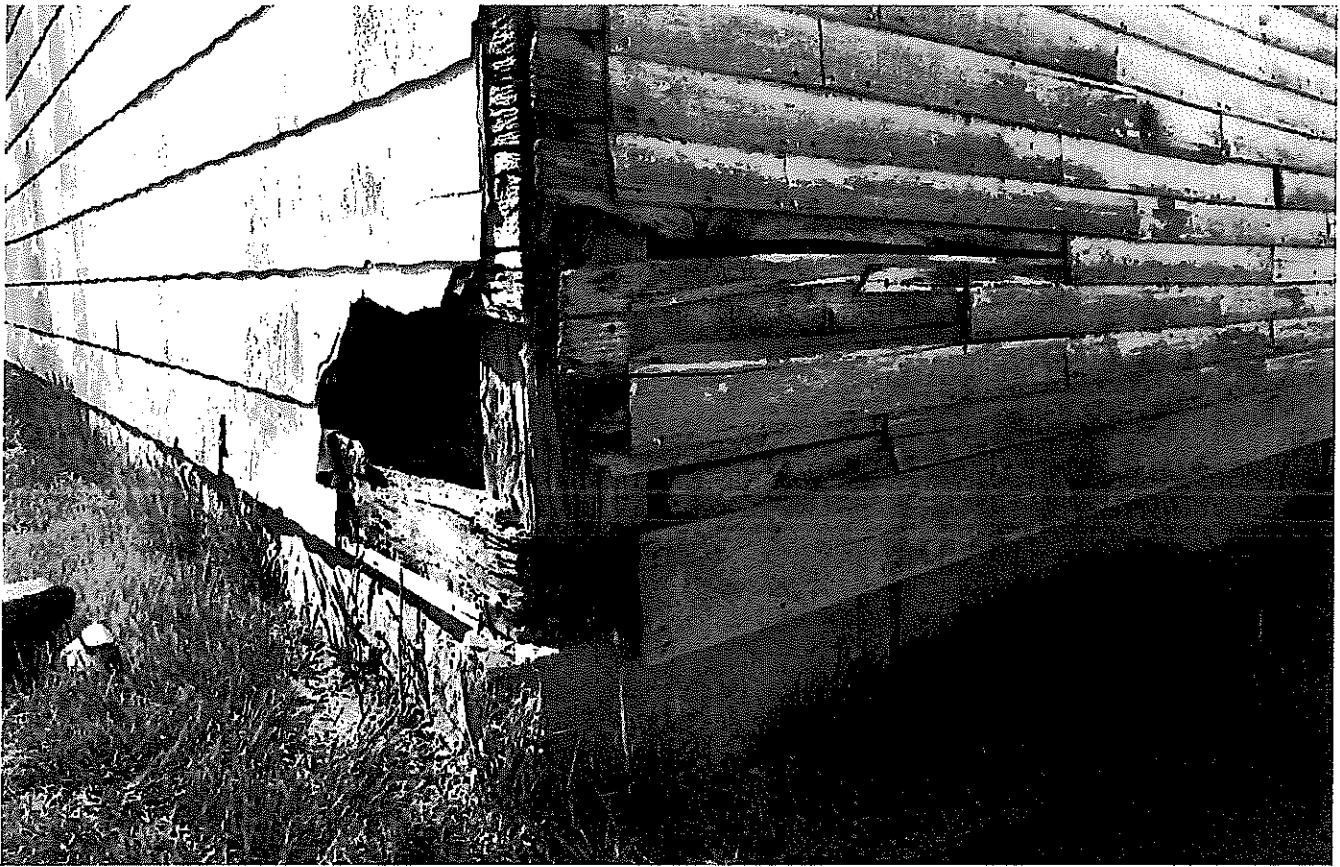
- S-2** South-east corner deterioration. 2017 Update: Shoring was not performed in this area and still remains compromised. 2013: Severe deterioration is evident in the south-east corner due to a breach in both the siding and cornice / roof in this area. There is very little integrity left in the sill or post-base, and eave beam and connecting rafters also appear to be compromised. The roof load in this corner has been shed to the adjacent studs; *however the sill, post, braces and possibly eave beam and rafter tails in this area must be replaced to restore full integrity. See below for discussion of immediate make-safe repair recommendations.*

S-2 Deterioration at south-east corner (2017)

to the south-east corner and at the failed members below the former tower on the north elevation, particularly the currently unsupported roof purlins.

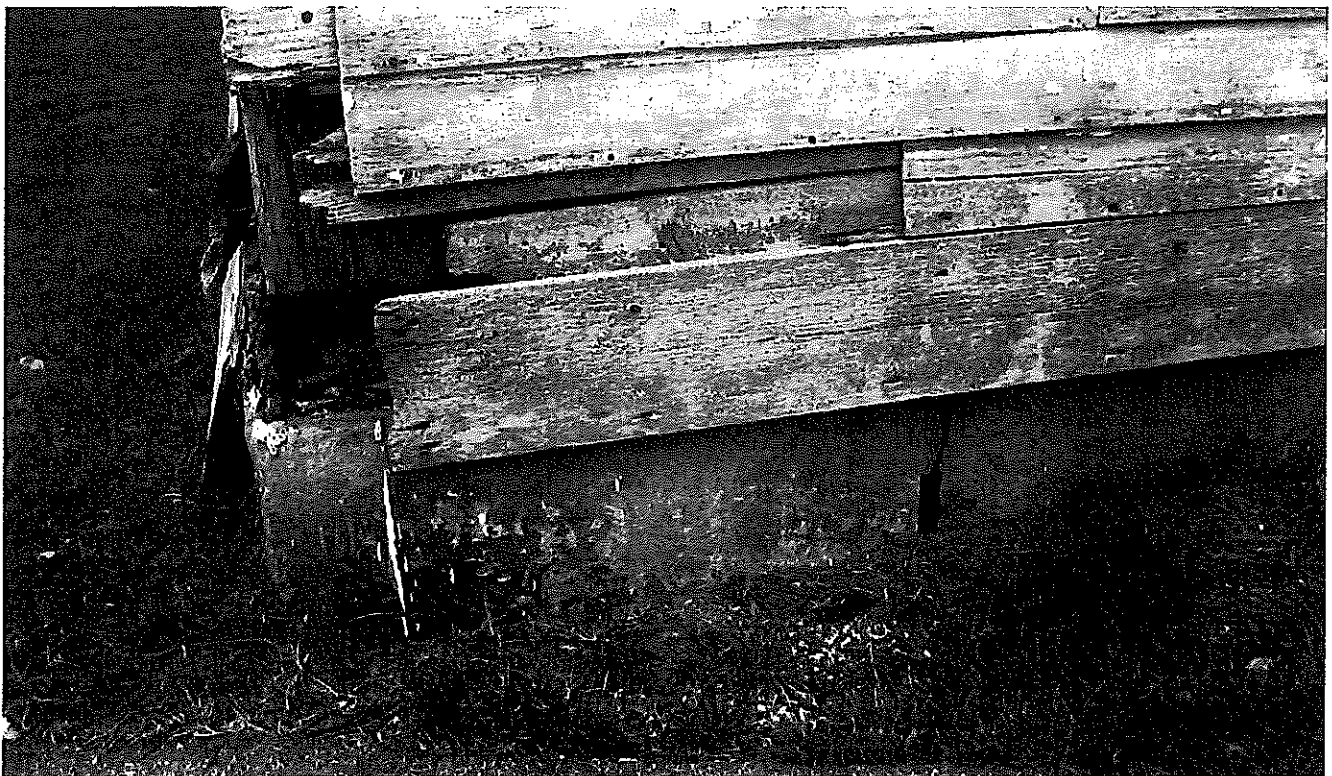
S-2 Deterioration at south-east corner (2013)

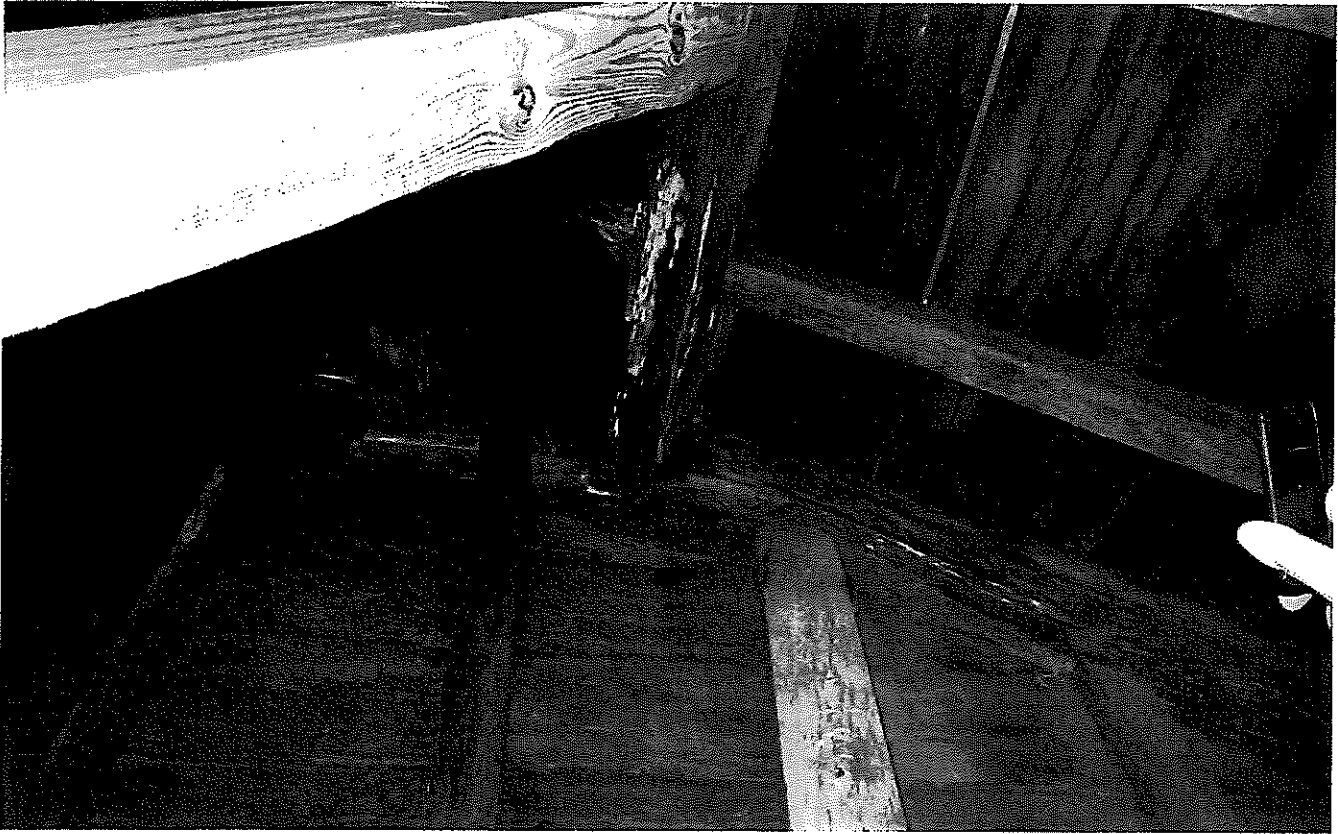
- S-3** Deterioration below tower. 2017 Update: Shoring was installed in early 2014. Deterioration of the framing has continued due to roof and siding breaches

creating additional areas of limited ability to support the end bay of the roof and north wall. Without structural intervention, there is no guarantee that this area can support snow, hurricane or seismic loads, and with continued deterioration this area may lose its ability to support its own dead loads. 2013: The roof and wall framing on the north elevation that once supported the tower has seen severe deterioration due to breaches in the roofing and siding. The raking end rafters have severed where the mid-slope purlin frames in on both east and west sides. The west side remains unsupported and the east side is shored with a temporary, but undersized, stud. The wind girt running at eave level is also severely compromised. *We recommend that all compromised members be replaced. Should a comprehensive restoration plan include resetting the tower, the former tower posts should all be assessed for condition and integrity. See below for discussion of immediate make-safe repair recommendations.*

S-3 Deteriorated rafter and purlin connection on east slope of north wall with shoring (2017)

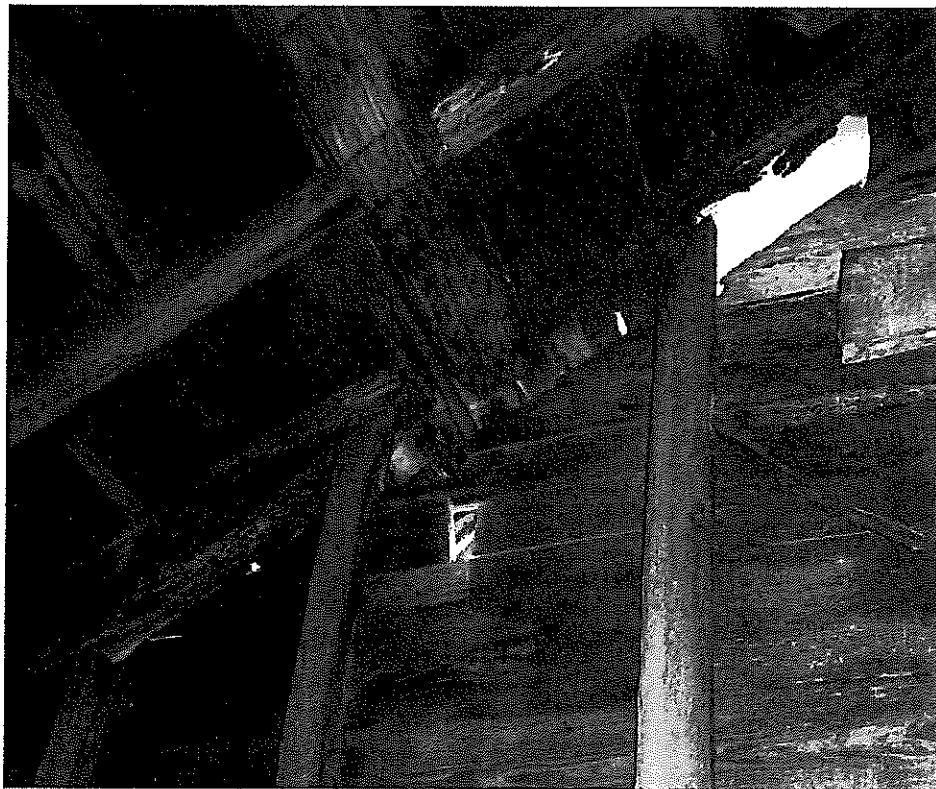
S-3 Deteriorated rafter and purlin connection on west slope of north wall (2013)

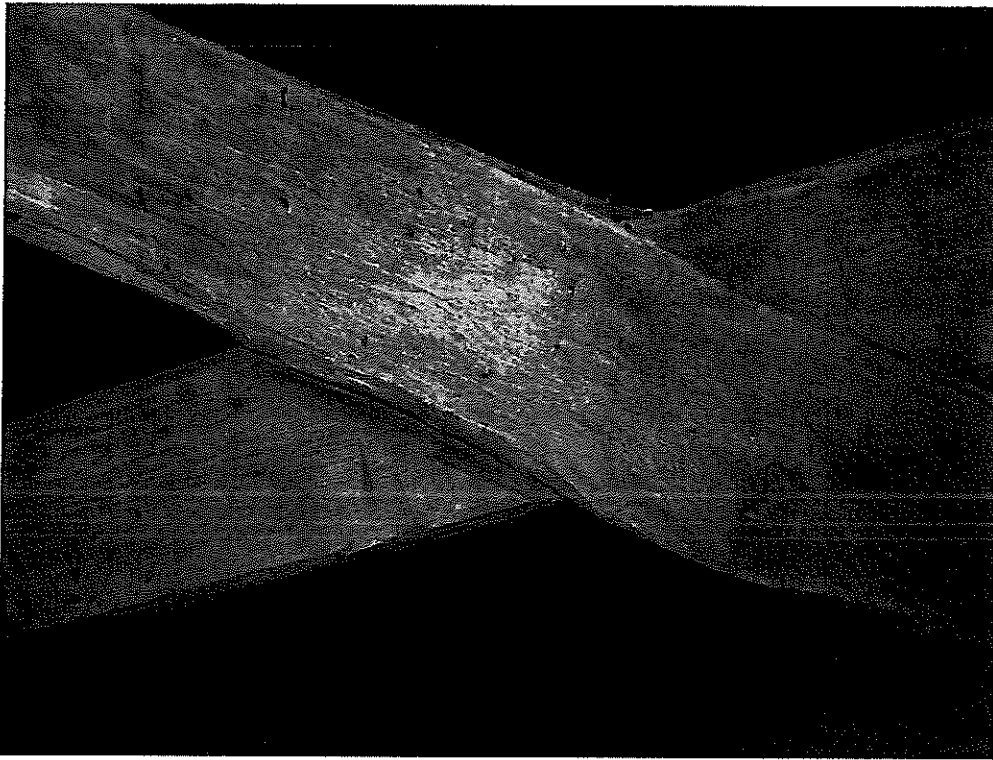
- S-4** Scissor truss separation. 2017 Update: Eave to eave cables were installed in early 2014. We were not able to evaluate whether lateral thrust loads are currently being supported by existing truss joinery at the eaves, or if joinery failures have occurred causing thrust loads to be transferred to cables. 2013: By nature scissor trusses have a tendency to spread due to the indirect orientation of the eave restraint, as opposed to direct eave to eave restraint typical of other truss types. In this case, I observed some minor separation at the scissor cross as well as some bowing at the eave on the east wall. I was not able to assess the integrity of the eave joint. *The truss should be more closely studied during a comprehensive restoration program to determine whether the joints require reinforcement. See below for discussion of immediate make-safe repair recommendations.*

S-4 Joint opening at east eave end of scissor-cross (2013)

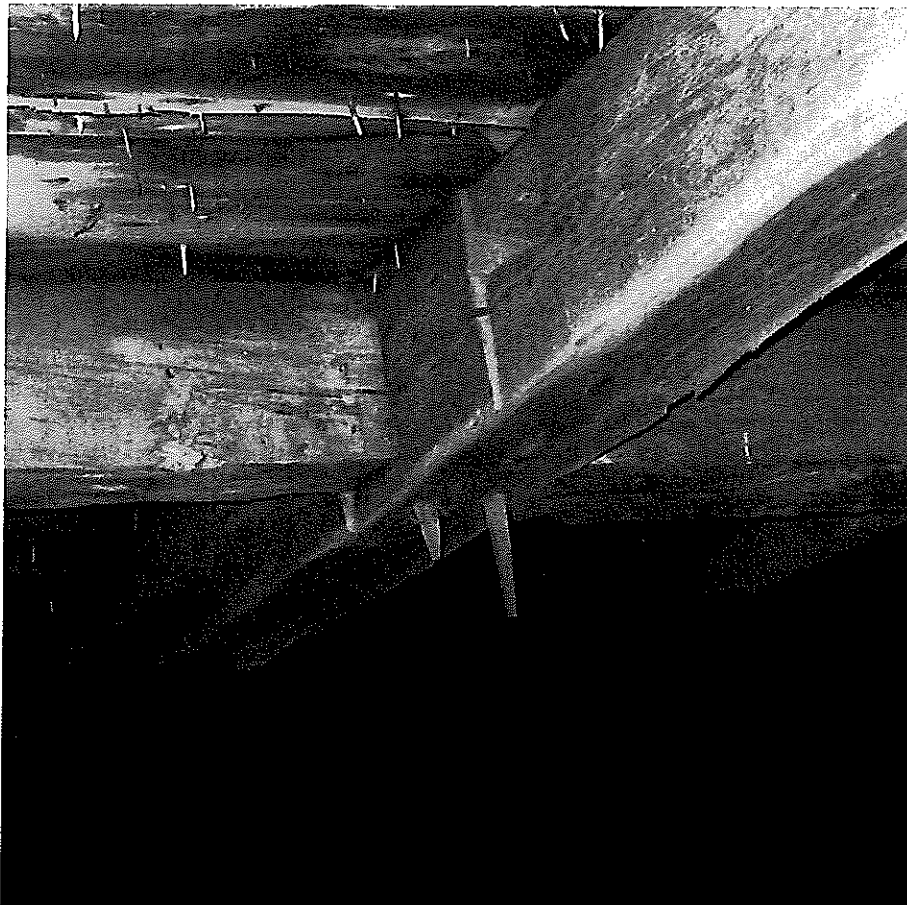
- S-5** Purlin Connection Splitting. 2017 Update: We did not observe any change in this condition. 2013: Horizontal splits are evident in the purlin at the connection to the trusses. The splits are evidence of a shear stress concentration where the purlin end is reduced into the mortise. *There are a number of joint reinforcement details that could be employed to address this problem during a comprehensive restoration project.*

S-5 Horizontal shear split in purlin end (2013)
